Commissioned Report No. – JRAD0416

Black Water of Dee fisheries and habitat study

Contractor: Scottish Power

Year of publication: January 2017

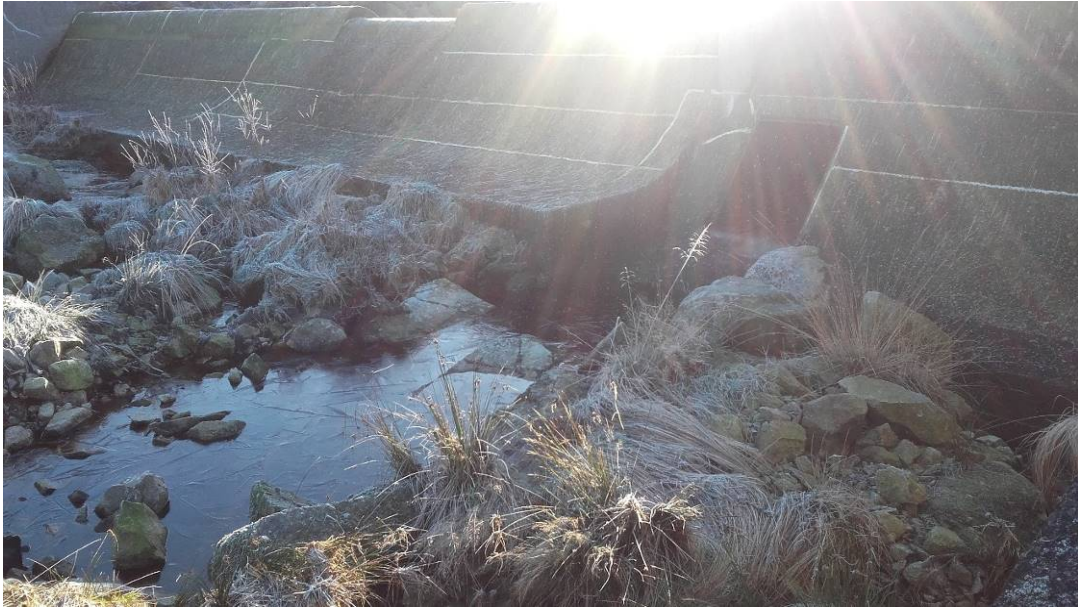
Figure 1: Downstream of dam at Pullaugh Burn, start point for habitat survey (NX 254418 574123)

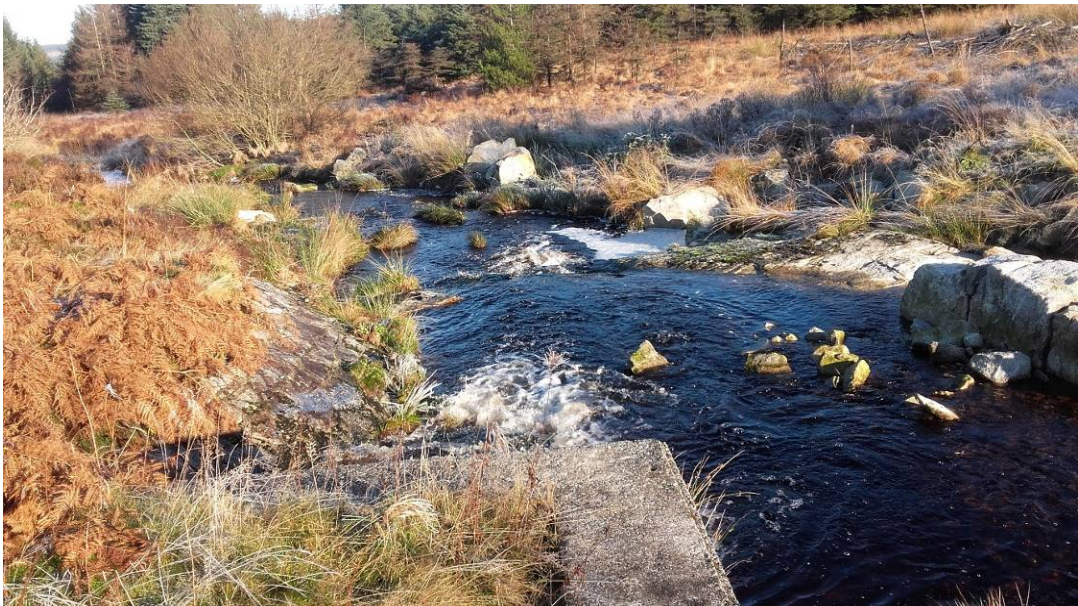
Figure 2: Downstream of dam, parr habitat with boulder and bedrock substrate (NX 254418 574123)

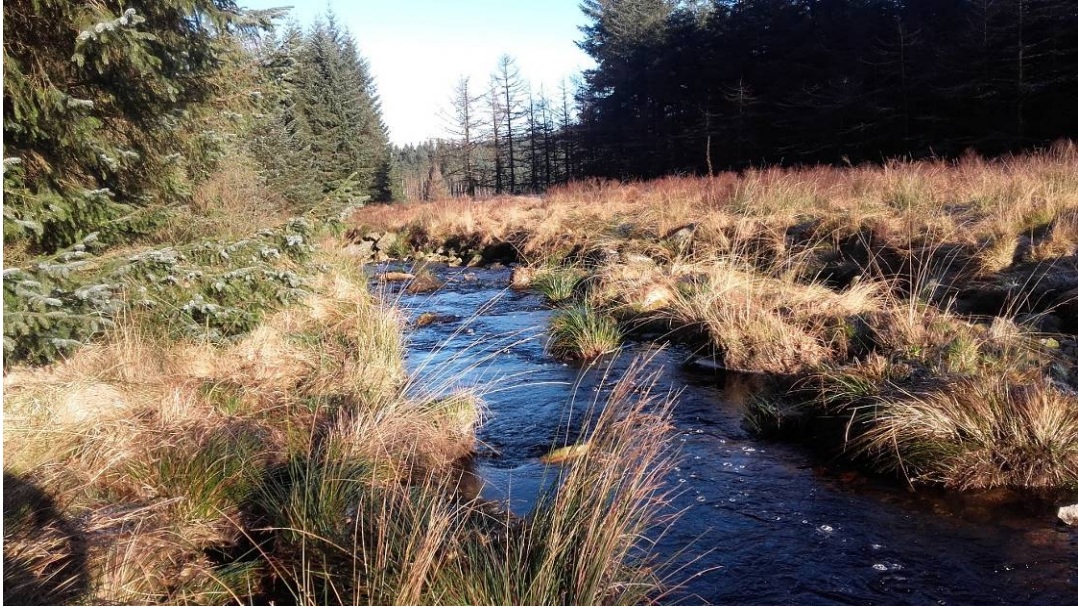
Figure 3: Example of run habitat suitable for parr, visible conifer plantations on both banks (NX 254398 574265)

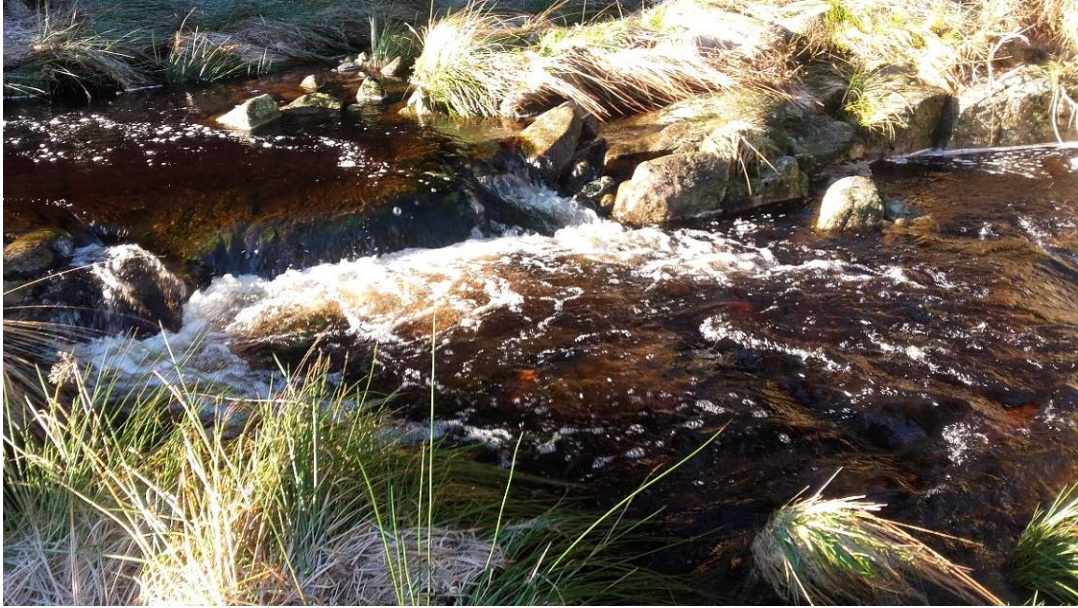
The habitat survey found that the Pullaugh Burn mainly hosts parr habitat, specifically run-riffle habitat with many small waterfalls over bedrock substrate (Figures 5 and 7). Some of these falls may cause problems for ascending fish travelling up the burn (Figures 7 and 9). Although there are various small sections where mixed juvenile habitat dominates (NX 254599 574778), the majority of the habitat appeared to be most suitable for parr. The substrates present were predominately bedrock and boulders with some small areas of cobbles and gravels. It appears that the increased compensation flow has dramatically improved parr habitat on the lower Pullaugh Burn. There was very little spawning habitat found in the Pullaugh Burn. There were several stretches of the burn which held small amounts of gravel (as seen in Figure 6) and others which had adequate flows for spawning sites however contained no suitable substrate (Figure 8). No clear spawning sites for trout or salmon were found along the burn.

Figure 5: Small waterfalls over bedrock with visible boulder substrate

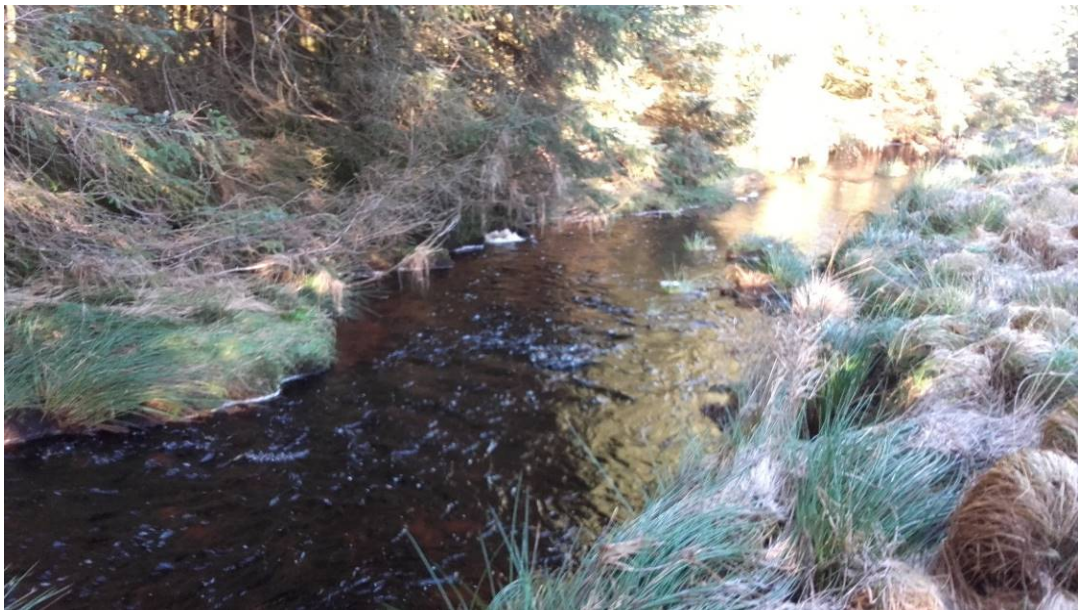
Figure 6: Mixed juvenile habitat (NX 254599 574778)

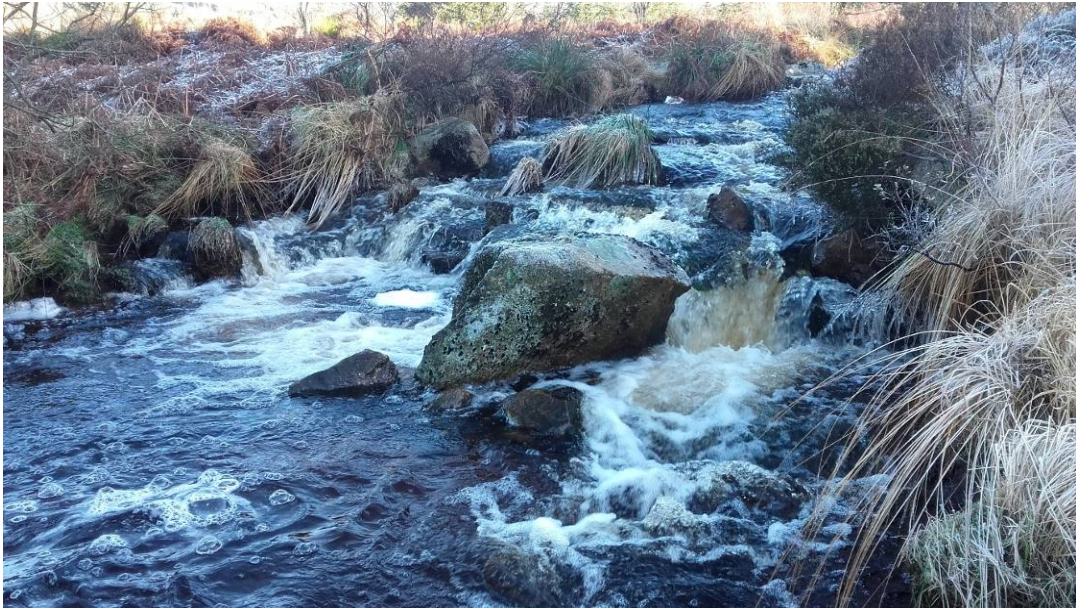
Figure 7: Example of small falls seen along Pullaugh Burn (NX 254406 574481)

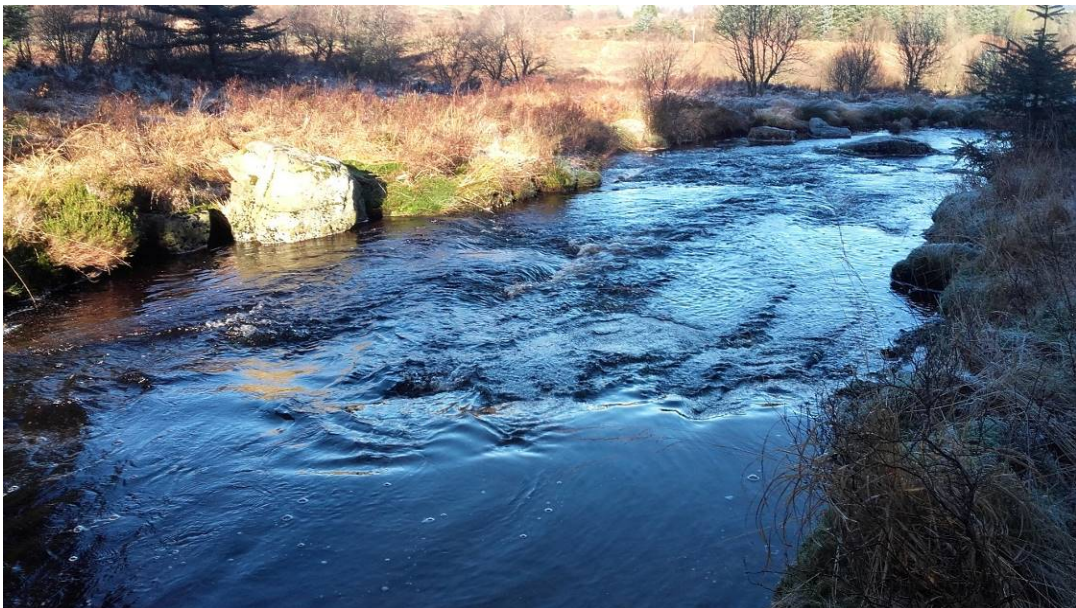
Figure 8: Areas of suitable spawning flows were found, however they lacked suitable small substrate (NX 25395 574423)

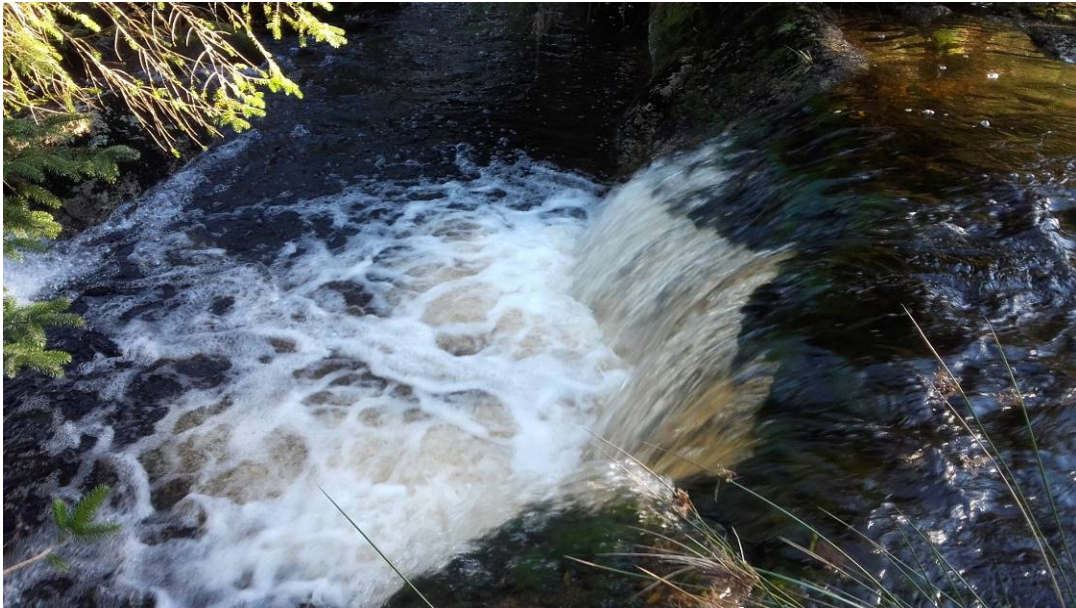
Figure 9: Larger falls seen at the bottom of the Pullaugh Burn, which may be a possible obstruction to fish movement at low water levels (NX 254966 574881)

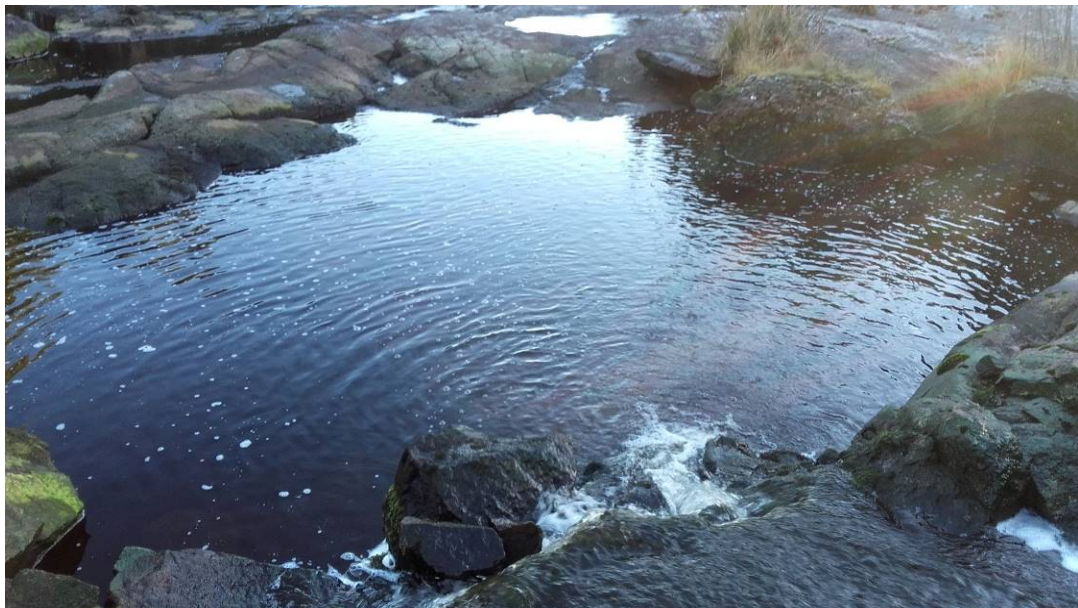
Figure 10: The Black Water of Dee at Clatteringshaws Dam facing downstream (NX 254528 575334)

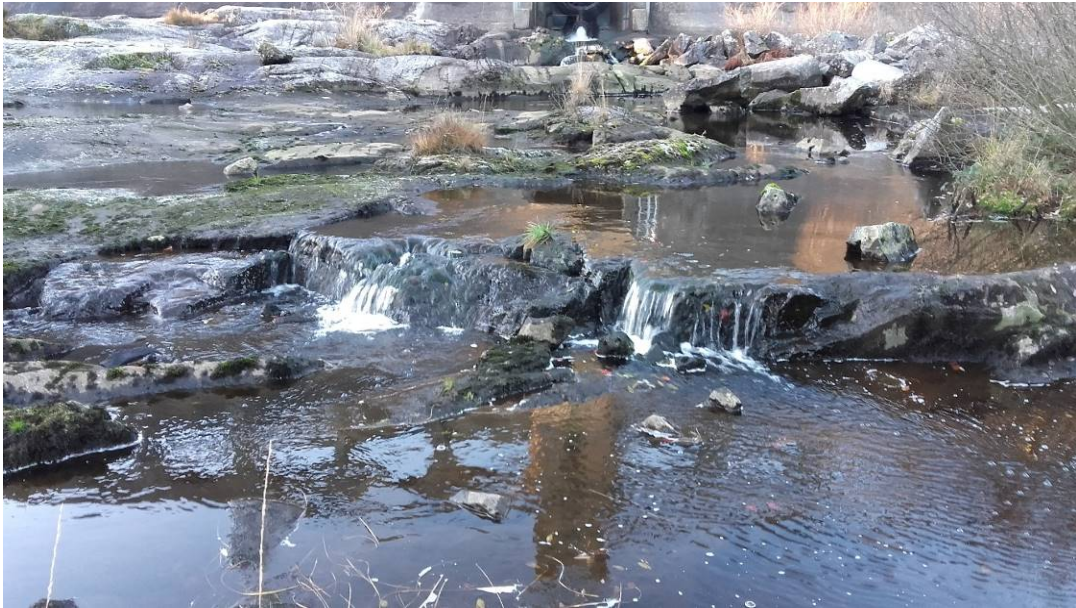
Figure 11: Pool/fall habitat below Clatteringshaws Dam

The initial flows found were pool and run habitats over a bedrock substrate (Figure 11). This continued for approximately 20 m before becoming glide habitat (Figure 12). The glide habitat continued to dominate until downstream of the A702 road bridge at NX 254712 575083, and from here run habitat started to develop (Figure 14). This section of river was then dominated by riffle-run habitats which characterised this stretch and created good parr habitat throughout (Figures 16 and 17). Bedrock and boulders were the predominant substrates found with very little cobble or gravel recorded. Falls were recorded along this section which may be obstructions to migrating fish at lower flow levels (Figures 14 and 18). Very little definite salmonid spawning habitat or fry habitat was identified however some areas were recorded which contained good flows and gradient but lacked smaller substrate (NX 755495 574744). The flows observed however were good in most areas resulting from the compensation flow now released from Pullaugh Burn and Clatteringshaws Dam. This has directly led to the abundance of parr habitat.

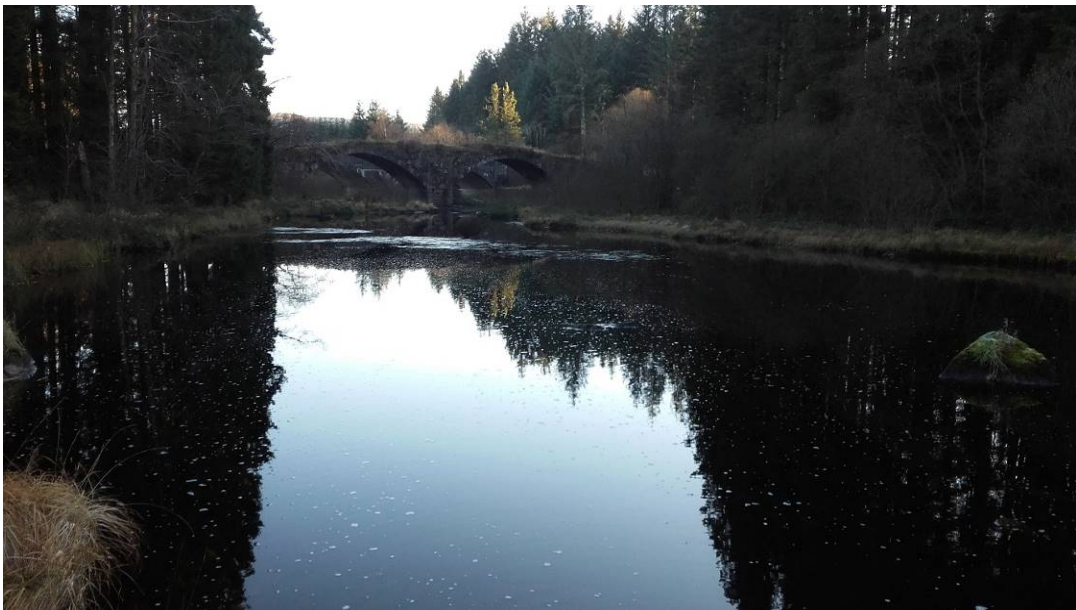
Figure 12: Glide habitat found downstream of Clatteringshaws Dam (NX 254583 575249)

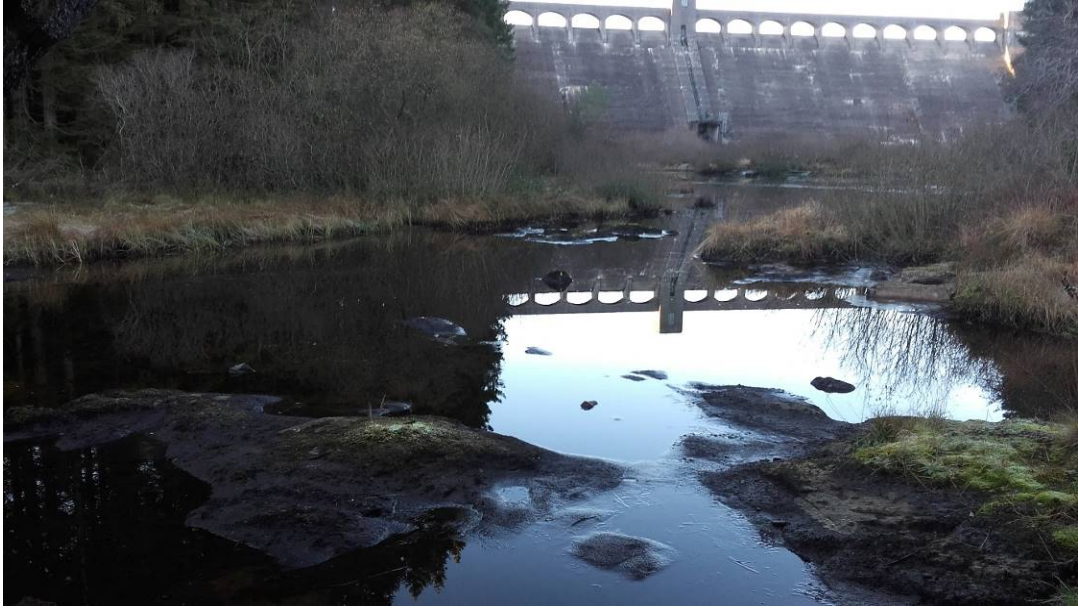
Figure 13: Directly under road bridge downstream of Clatteringshaws dam, glide habitat predominant

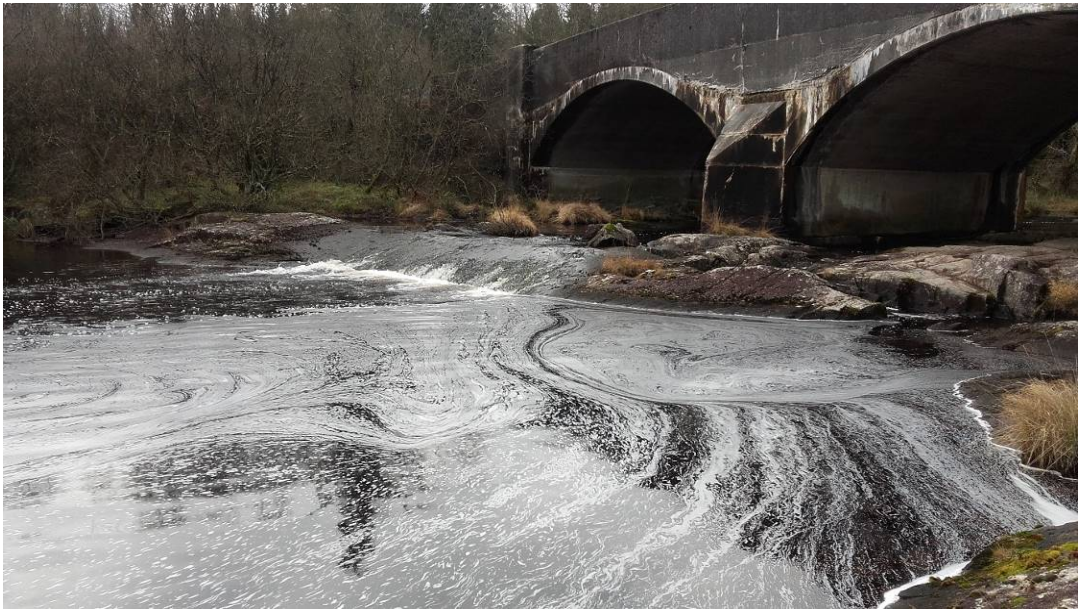
Figure 14: Directly downstream of road bridge at NX 254635 575176, obstruction of upstream migration due to bedrock falls

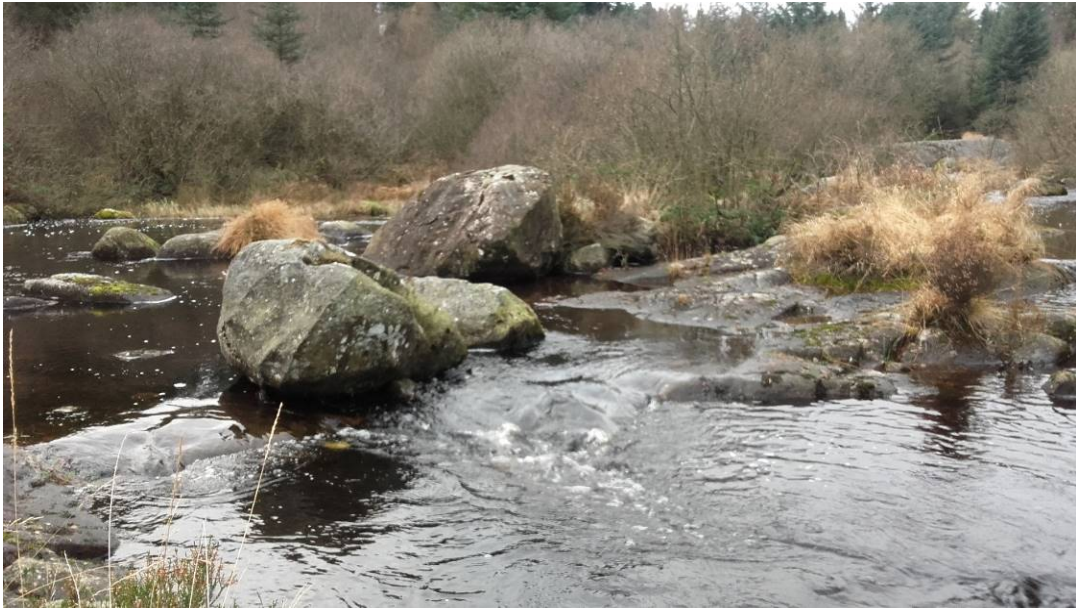
Figure 15: Run habitat beginning to develop, bedrock and boulder substrate visible (NX 254712 575083)

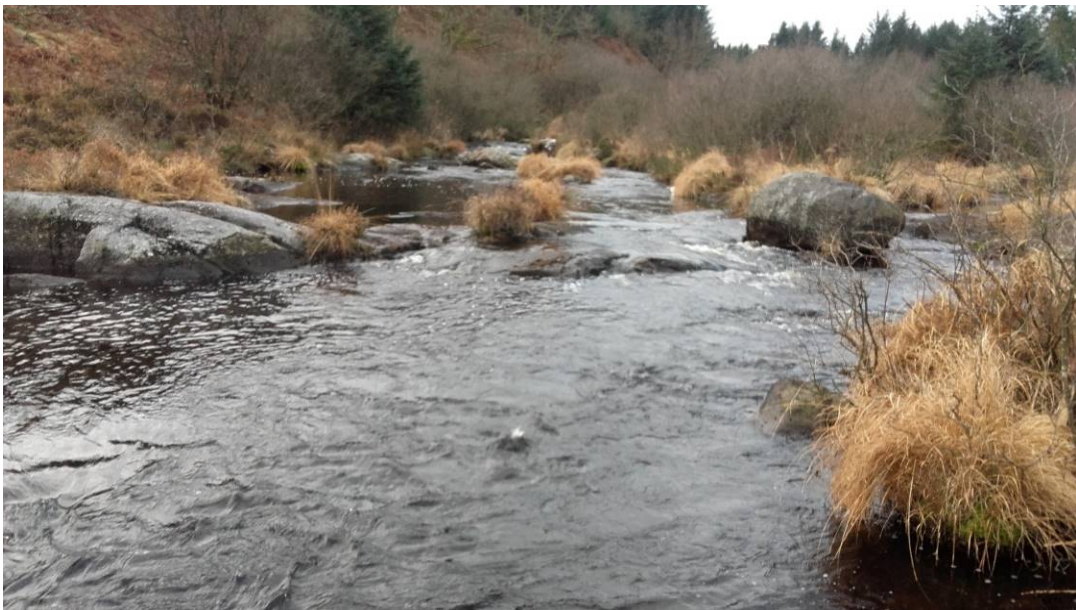
Figure 16: Example of run habitat seen throughout this section with large substrate

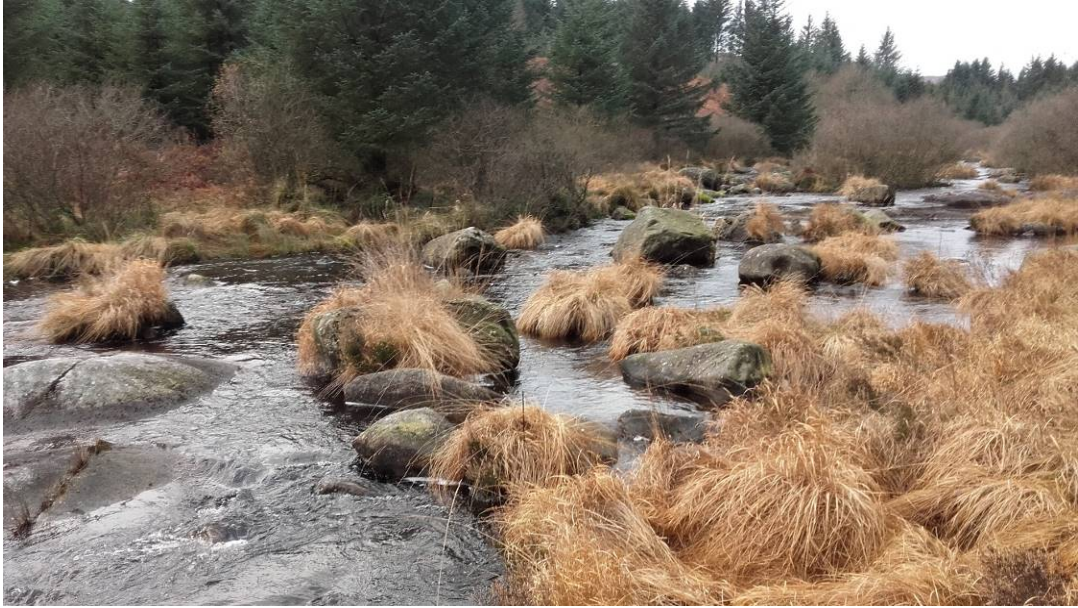
Figure 17: Conifer plantations can be seen close to the bank, a common occurrence along this stretch of river

Conifer plantations and naturally seeded conifers were abundant along this section (Figures 17, 18 and 19). At grid reference (NX 254994 574899) windblown conifers were also found lying across the river (Figure 20) and these should be removed. Bankside erosion was not observed along this section of river.

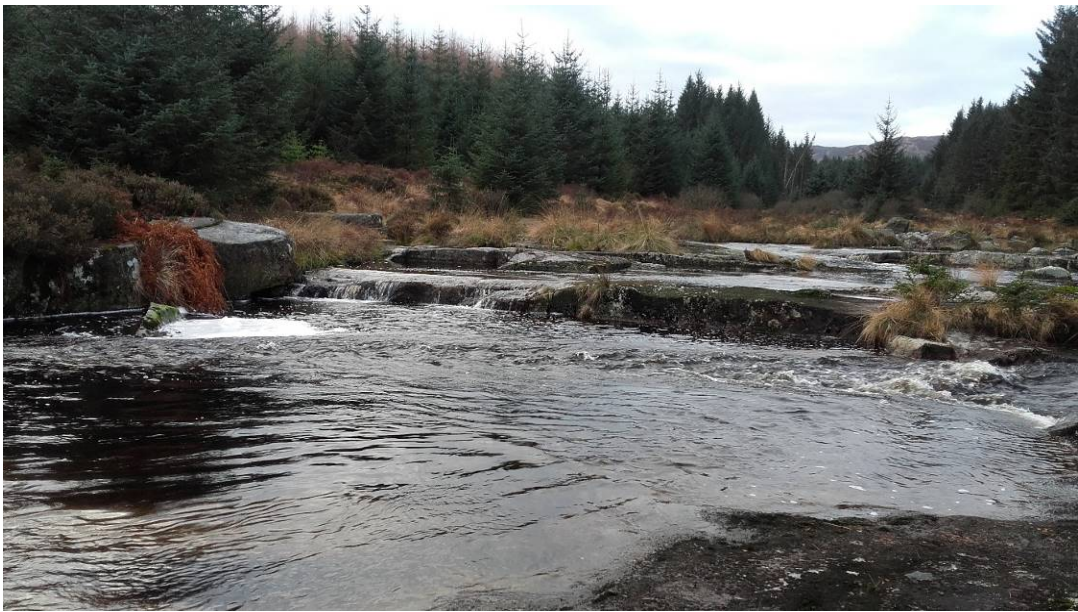
Figure 18: Difficult falls for ascending fish at (NX 255369 574769) with conifer plantations in the background

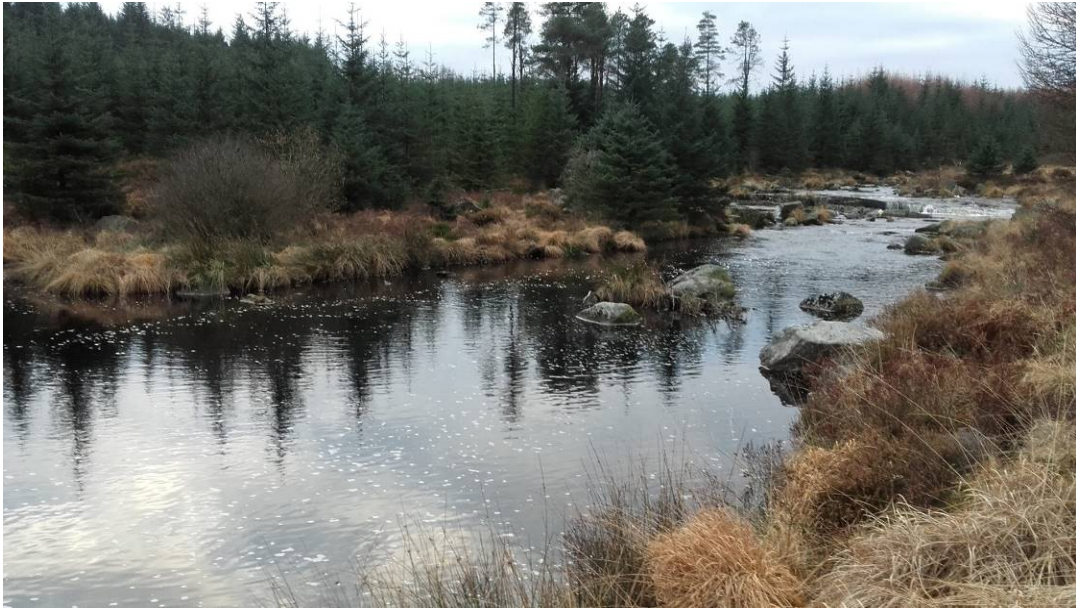
Figure 19: Area of glide found at the bottom of this stretch of river with conifer plantation and naturally regenerated conifers visible (NX 255688 574709)

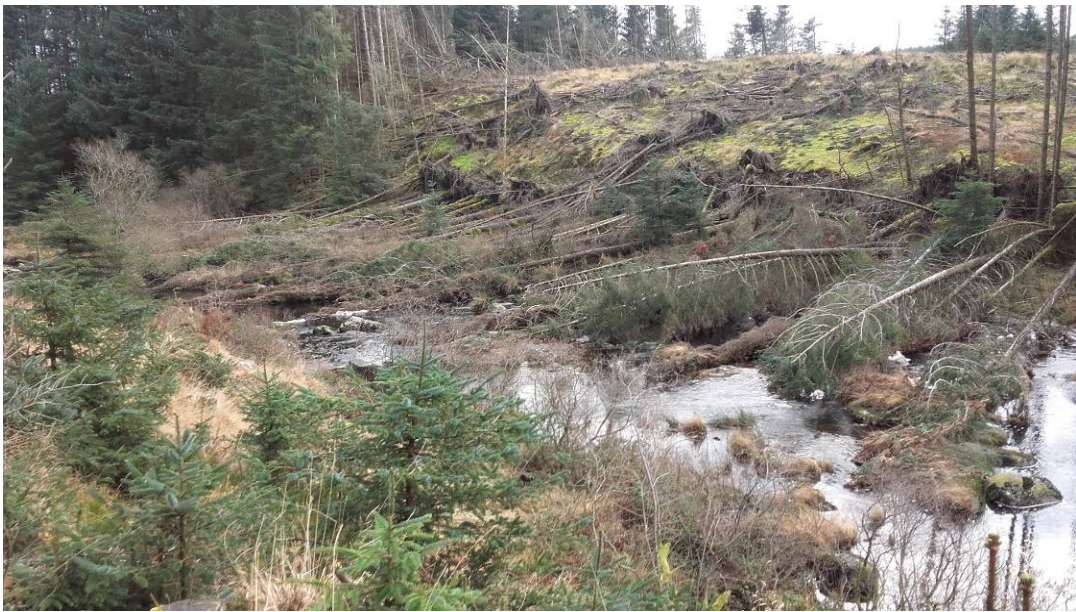
Figure 20: Windblown conifers lying across the Black Water of Dee (NX 254994 574899)

<p>Windblown conifers lying across the river at NX 254994 574899.</p>	<p>Remove fallen trees.</p>

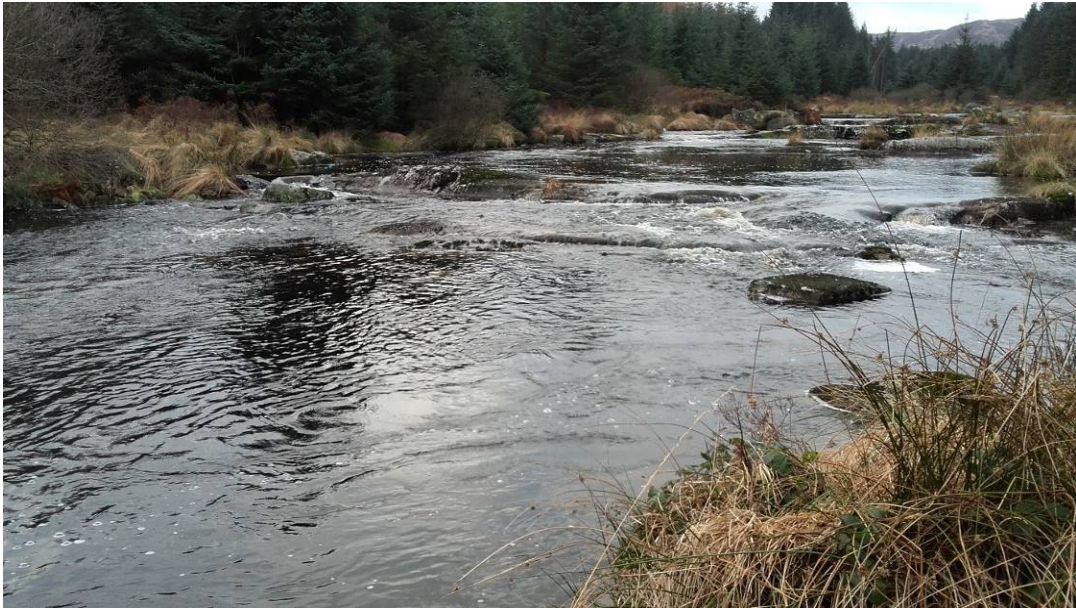
Figure 21: Good potential site for juvenile habitat however no small substrate was present, and flows are good (NX 255495 574744)

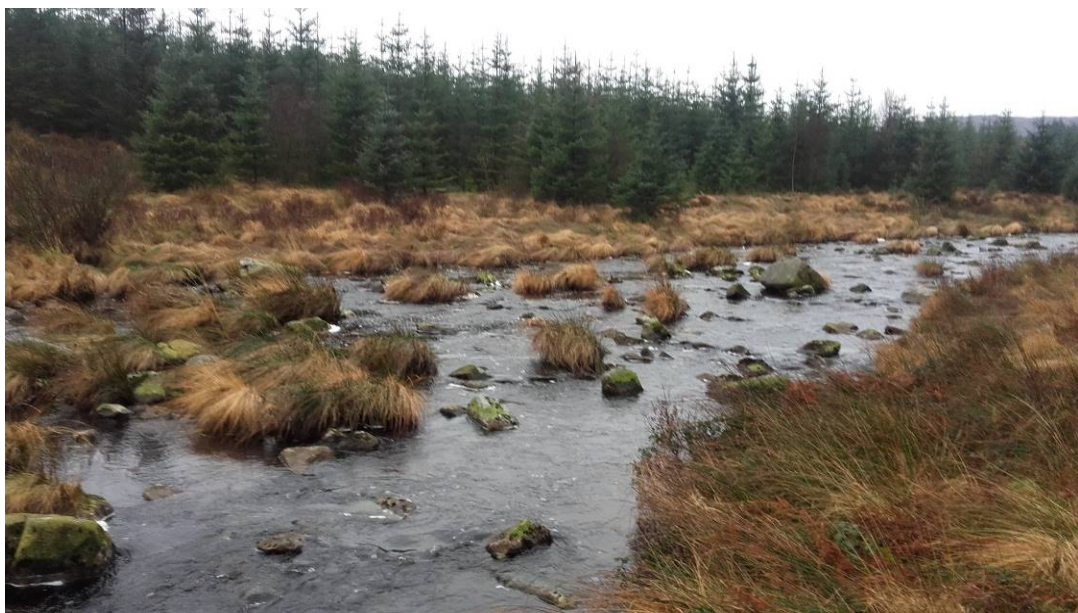
Figure 22: Example of run habitat with large substrate, conifer plantation also visible on the right bankside (NX 255917 574654)

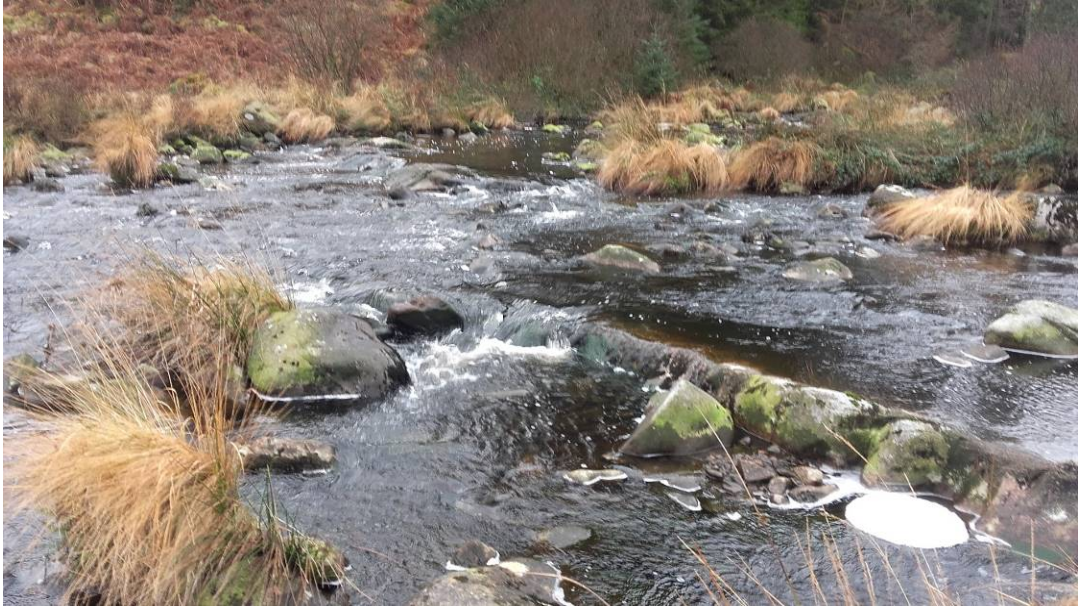
Figure 23: Bedrock falls at (NX 256118 574605) which make migrating upstream difficult for fish

This section of the Black Water of Dee was again dominated by parr habitat, mainly consisting of run-riffle habitats with large substrate (Figures 22, 23, 25 and 26). Small waterfall sections were also recorded along the surveyed section (Figures 23, 28 and 29). The most abundant substrates recorded were boulder and bedrock with a few areas containing small amounts of cobbles and gravels. The smaller substrate was very limited in area and was spread out throughout the section surveyed (Figure 24). The source of the smaller sized substrate was the various smaller tributaries. The areas of gravels were the first, i.e. most upstream, to be recorded during the survey of the Black Water of Dee.

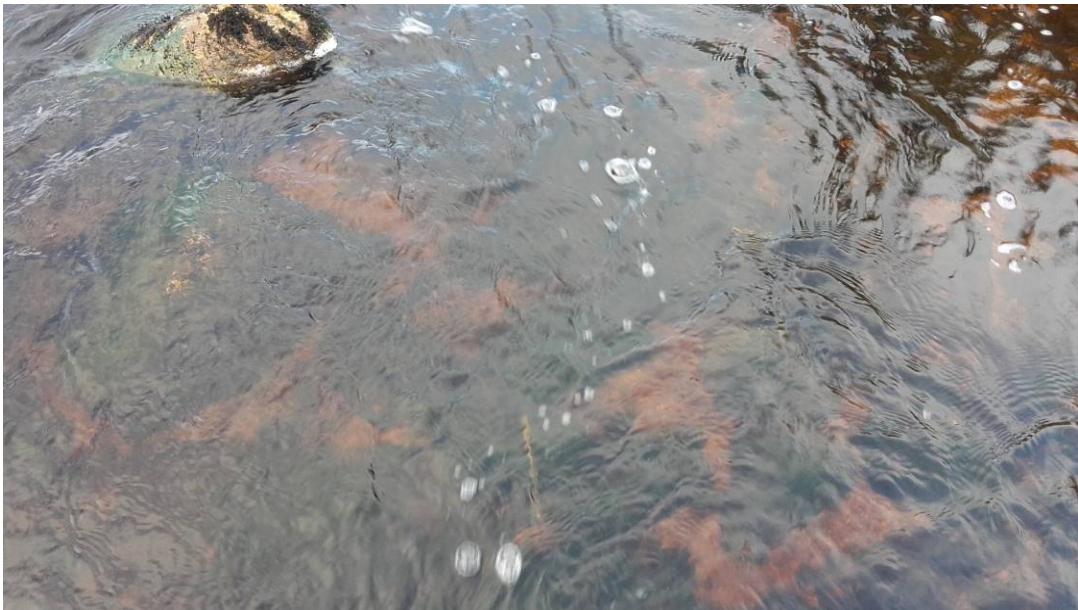
Figure 24: Gravel sections observed at (NX 256336 574486), these may be very important areas as suitable spawning substrate was seen to be lacking overall

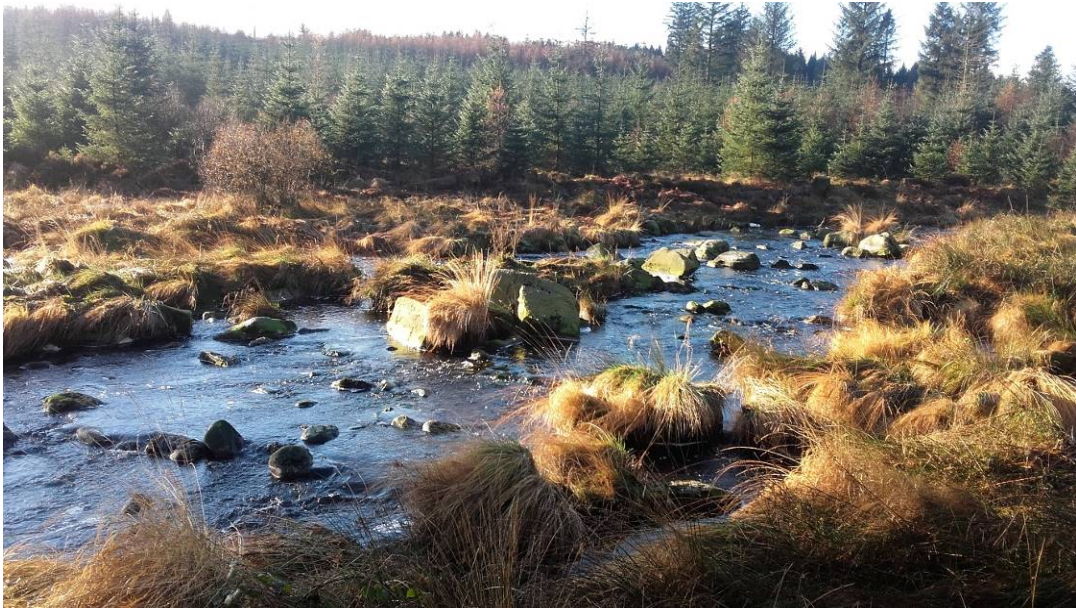
Figure 25: Example of the parr habitat with large substrate and conifer plantations that were found to be predominant features throughout this section (NX 256497 574414)

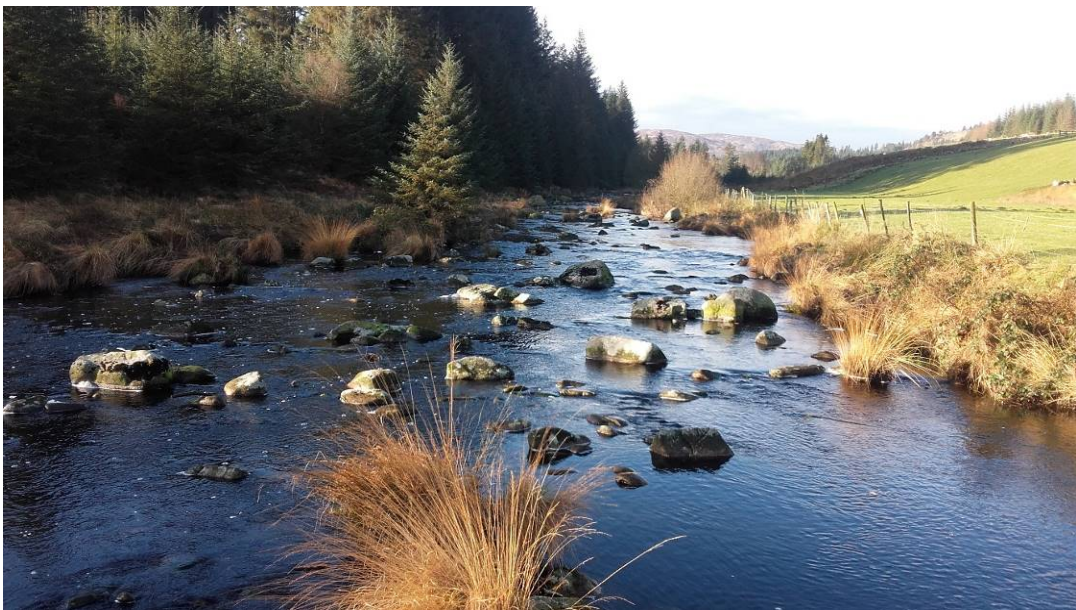
Figure 26: Parr habitat with conifer plantation and naturally re-generating conifer on the right bank (NX 257065 574138)

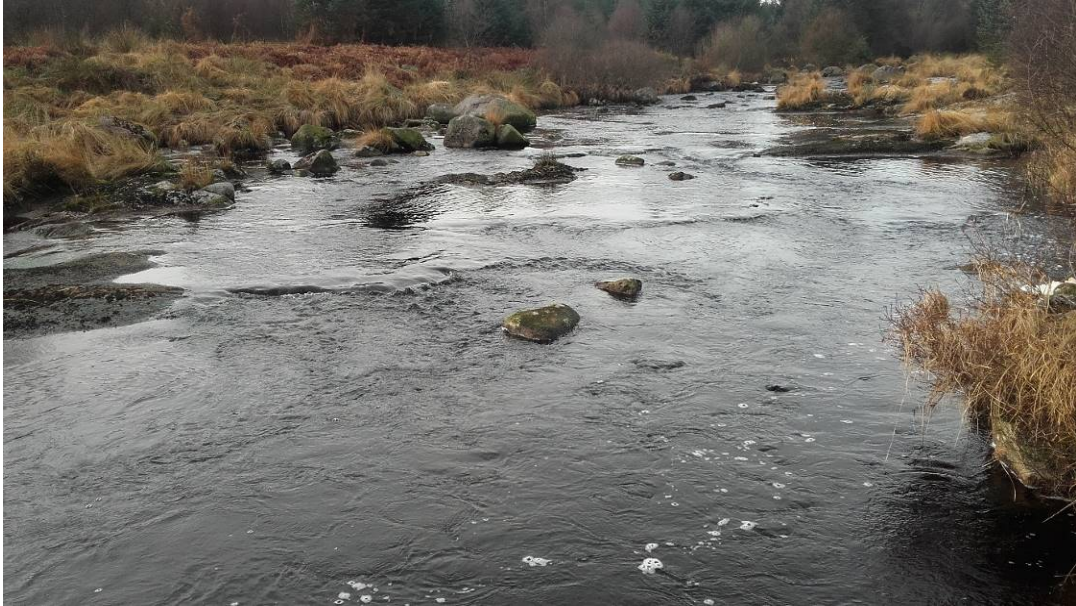
Figure 27: Example of flows and gradient suitable for fry or spawning habitat but with a distinct lack of small substrate present (NX 257801 573563)

Very little habitat suitable for spawning by salmonids was recorded within this section of river. Although some areas appeared to have suitable flows for spawning purposes (Figure 27), there was an overall lack of gravels and small substrates limiting its suitability. This area close to Holly Island (NX 258205 573432) consisted mainly of falls and pool habitat (Figures 29 and 30) with bedrock recorded as the predominant substrate. Some of these falls may cause an obstruction to migrating fish during usual compensation water flows in dry weather. The lack of water depth immediately below these bedrock falls make passage through them difficult for fish during lower flows. It was found that the recent increased flow of compensation water has created an abundance of parr habitat along this section of the Black Water of Dee.

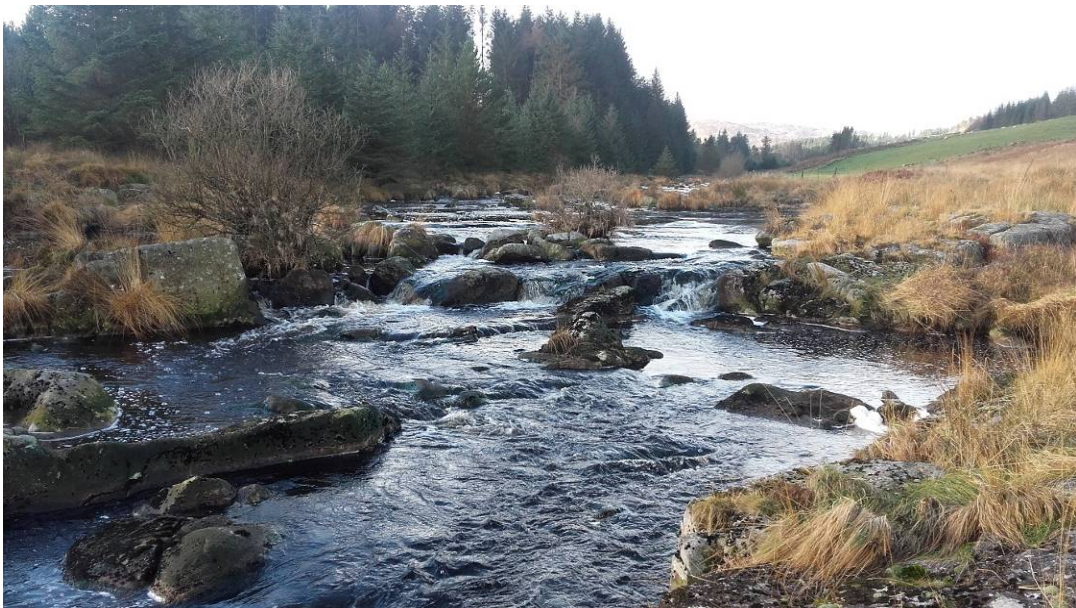
Figure 28: Waterfall with large substrate found at (NX 257065 574138) which may be problematic to migrating fish under usual flows

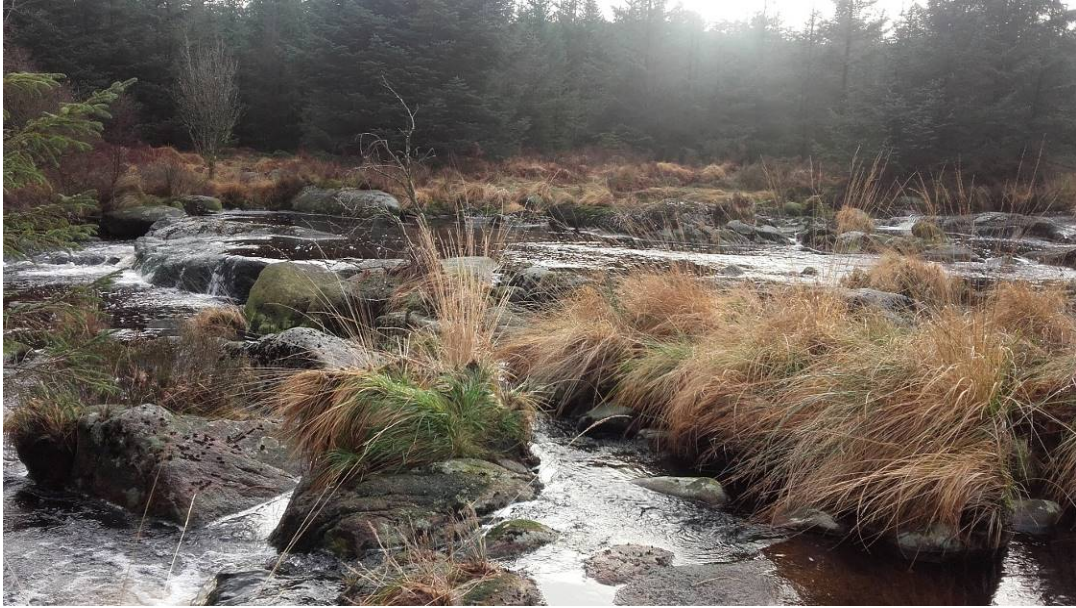
Figure 29: Bedrock substrate with stepped falls, this may be an issue for migrating fish. Also note the conifer plantation seen close to the bankside (NX 258205 573432)

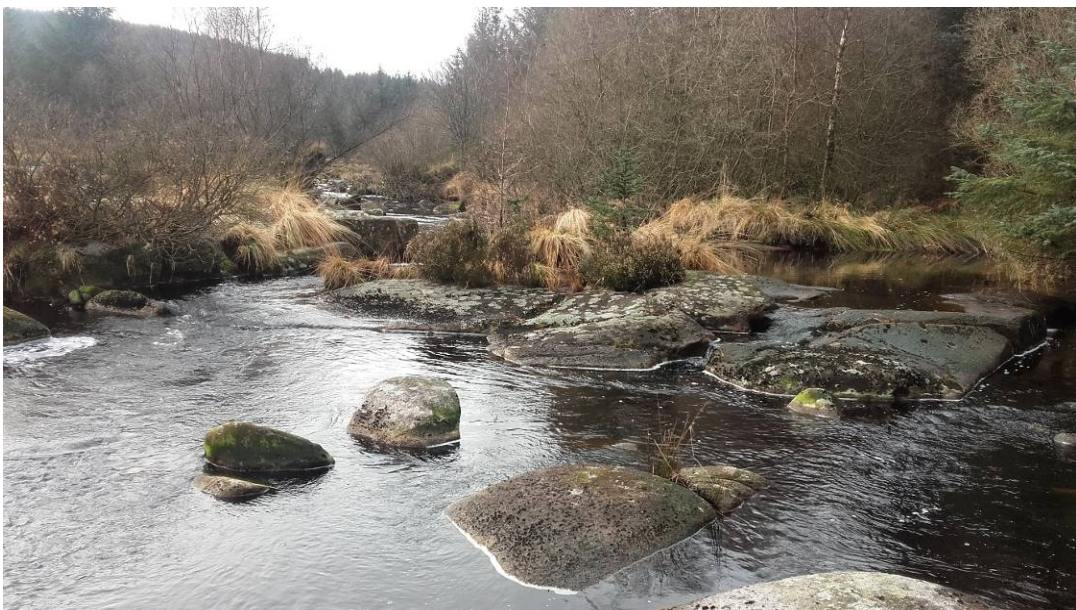
Figure 30: Bedrock area with small falls which may be an obstruction to fish migration (NX 258205 573432)

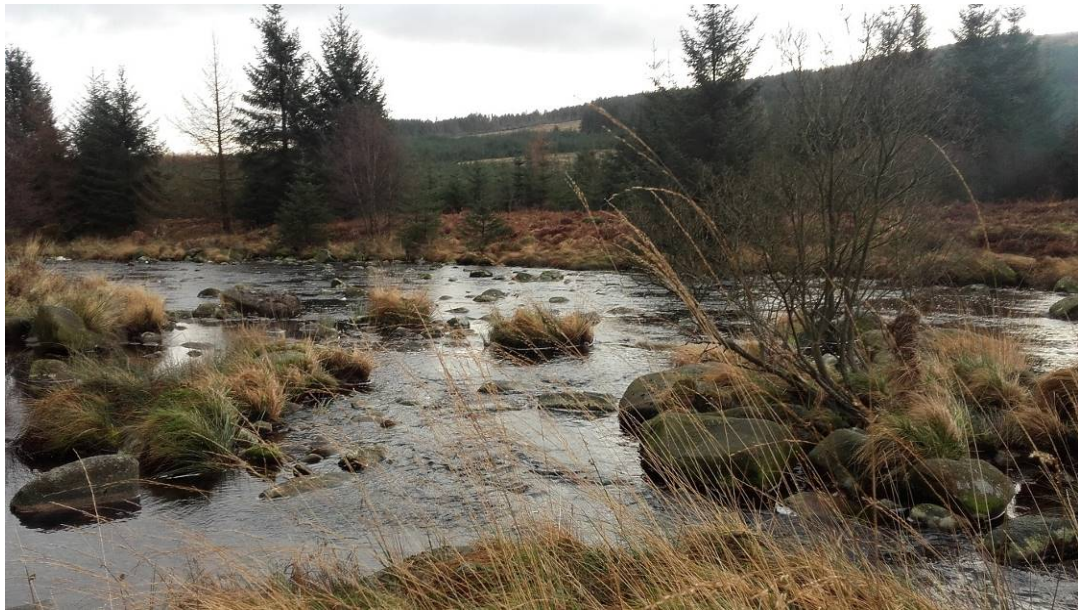
Figure 31: Start of survey, large substrate with run-riffle parr habitat. Naturally re-generating conifers seen on right bank (NX 258258 573432)

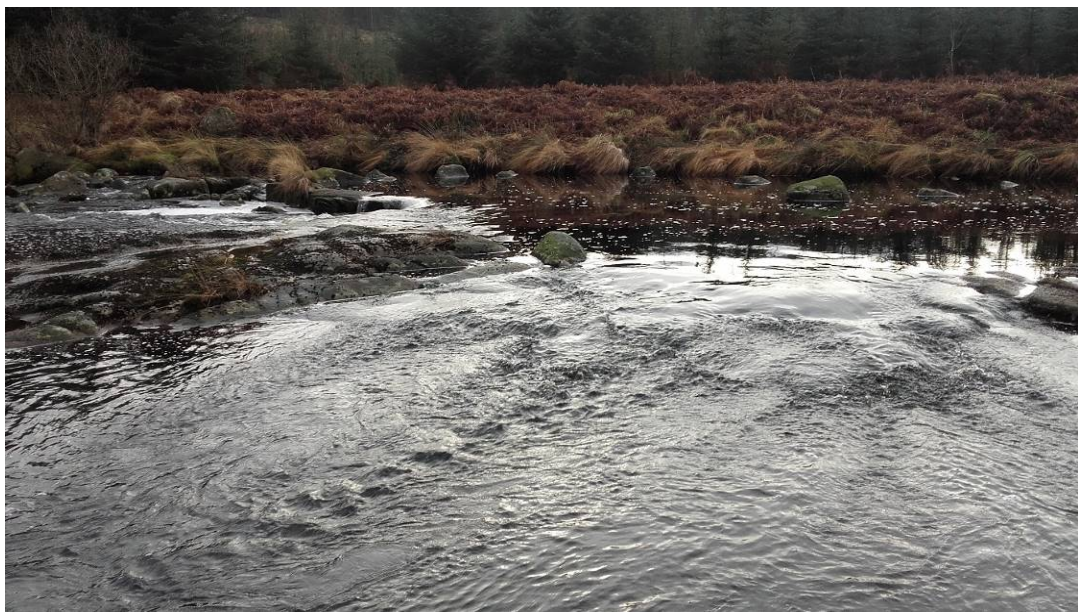
Figure 32: Great flows, gradient and depths for fry habitat and spawning habitat but flowing over bedrock substrate (NX 258381 573451)

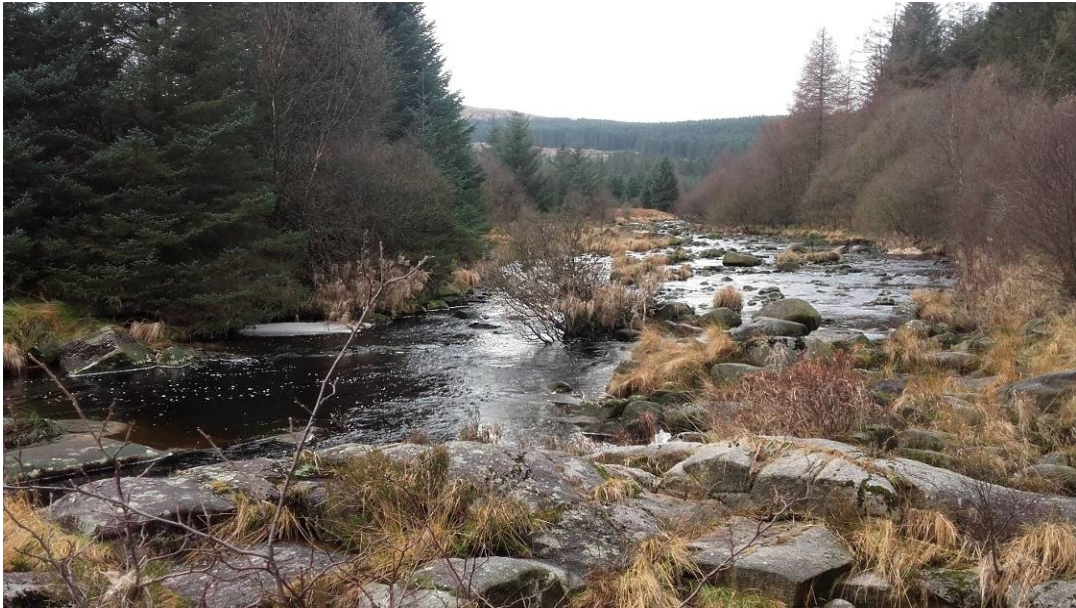
Figure 33: Parr habitat with large substrate, riffle-runs and conifer plantations on both banksides (NX 258565 573494), some deciduous trees can also be seen
