Commissioned Report No. – JRAD0416

Black Water of Dee fisheries and habitat study

Contractor: Scottish Power

Year of publication: January 2017

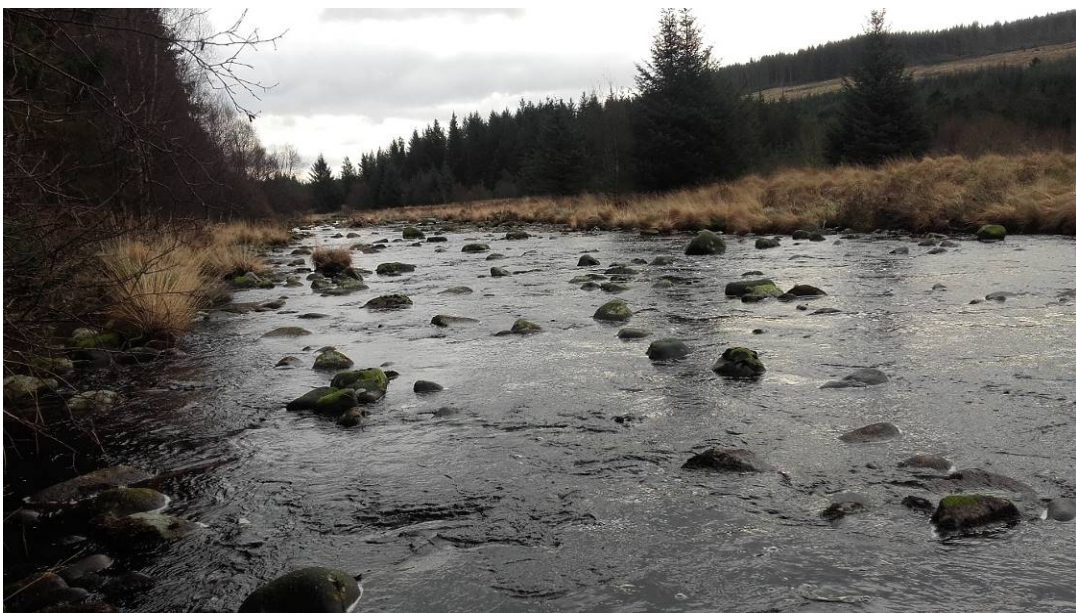
Figure 34: Parr habitat with boulder and cobble substrate, both conifer plantations and naturally regenerating conifers can be seen here (NX 259018 573715)

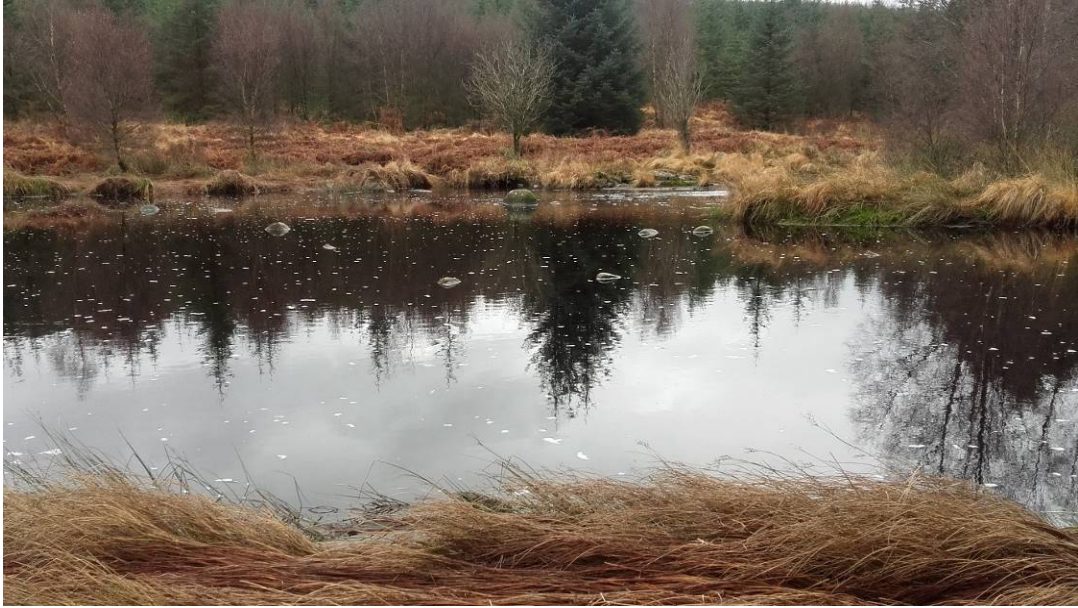
Figure 35: Glide habitat found at NX 259360 573571 stretching down to the 'Otter Pool' area

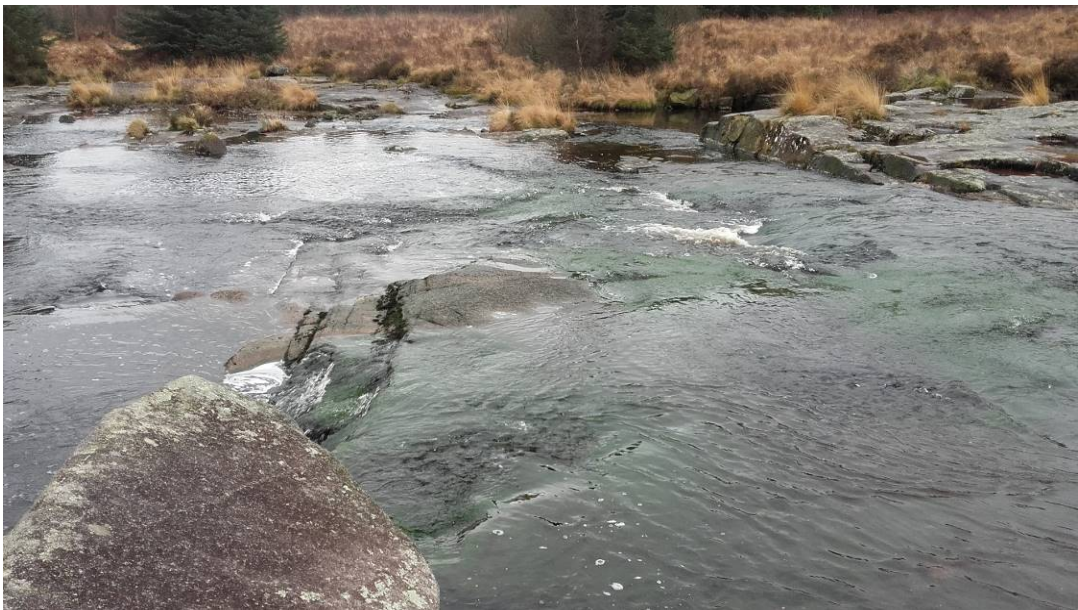
Figure 36: Bedrock falls section found at the 'Otter Pool' area (NX 259441 573576). This will be an obstruction to migrating fish at usual flows as water was very shallow over the bedrock outcrops

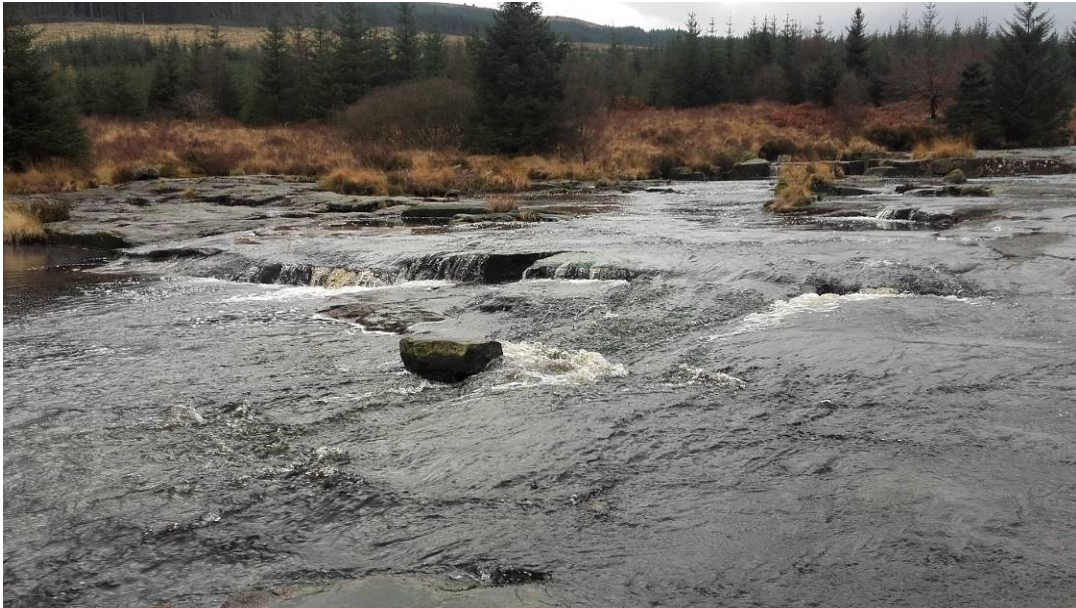
Figure 37: Obstruction to fish migration found at the Otter pool, these bedrock falls appear to be impassable in base flow (NX 259491 573583)

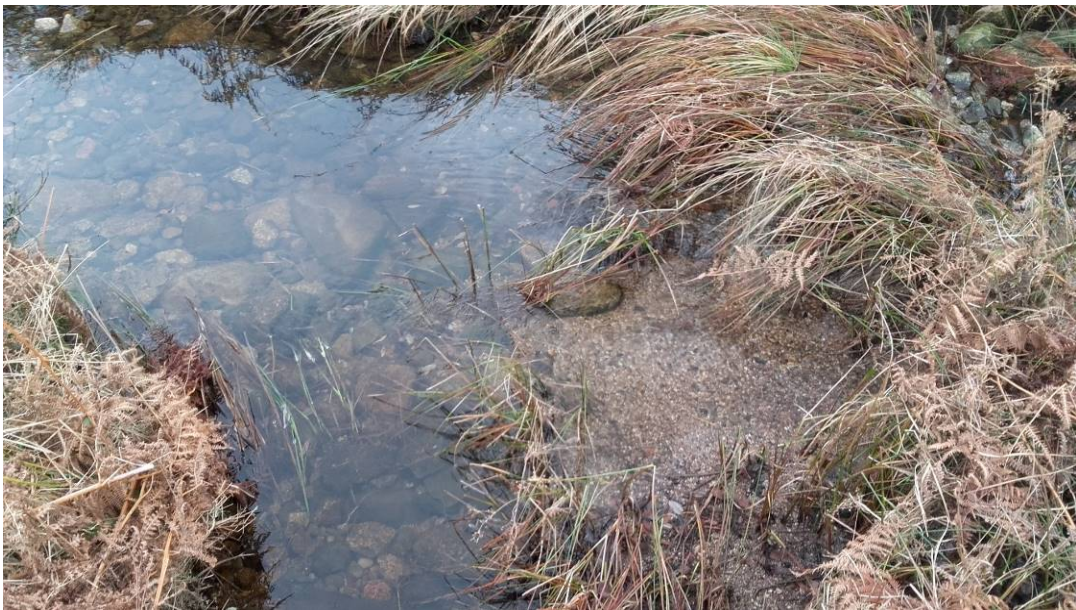
Figure 38: Example of gravel filled burns which flow into the river, these should be important areas for trout spawning (NX 259702 573645)

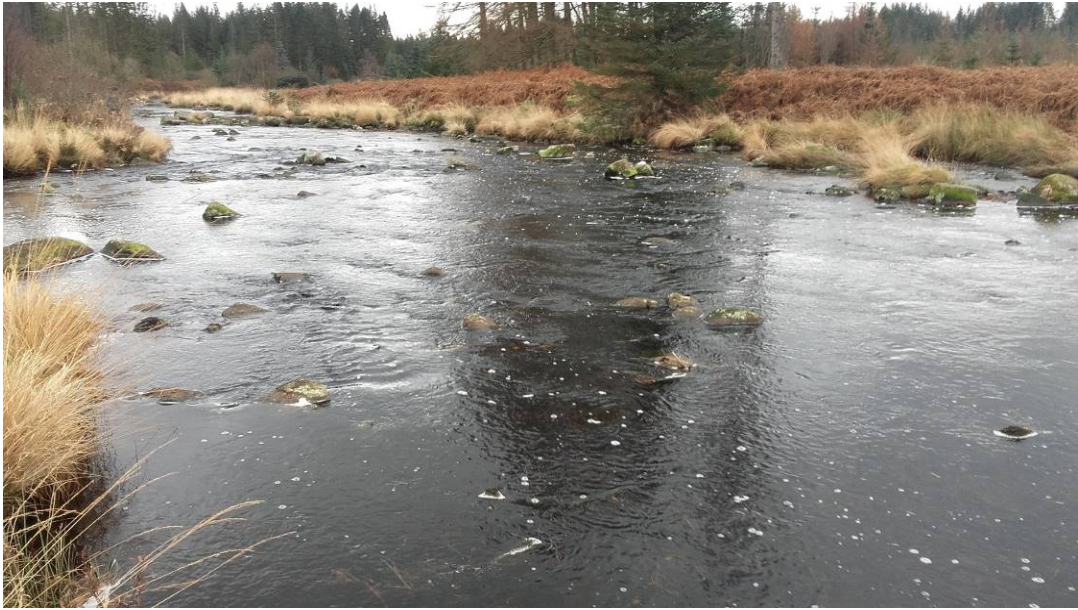
Figure 39: Return to parr habitat downstream of 'Otter Pool' area, large substrate with natural regeneration of conifers on right bank (NX 259825 573587)

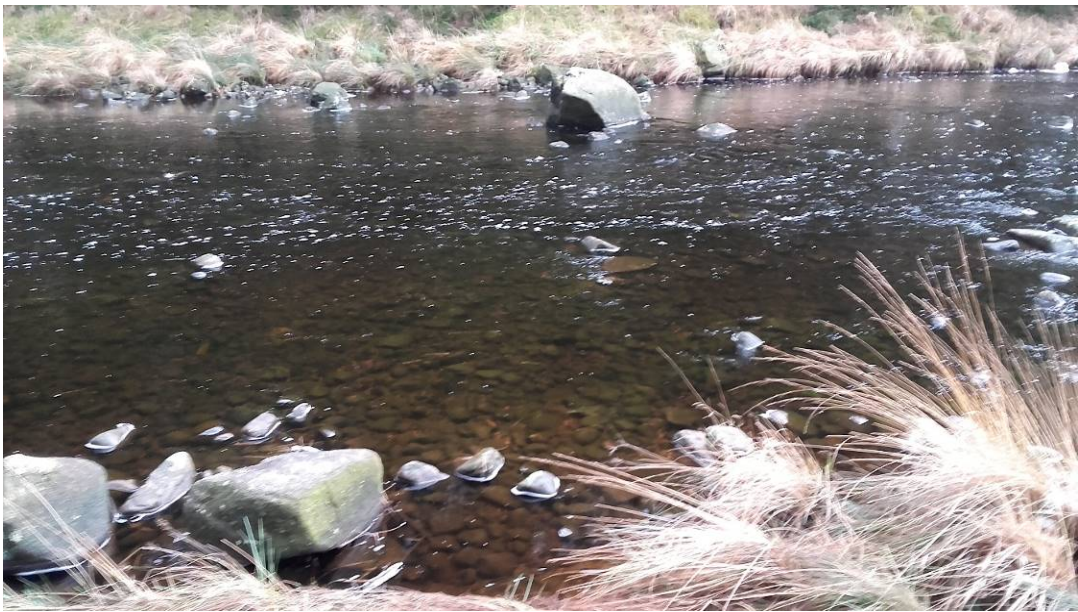
Figure 40: Parr habitat found with a cobble and boulder substrate (NX 260300 573364)

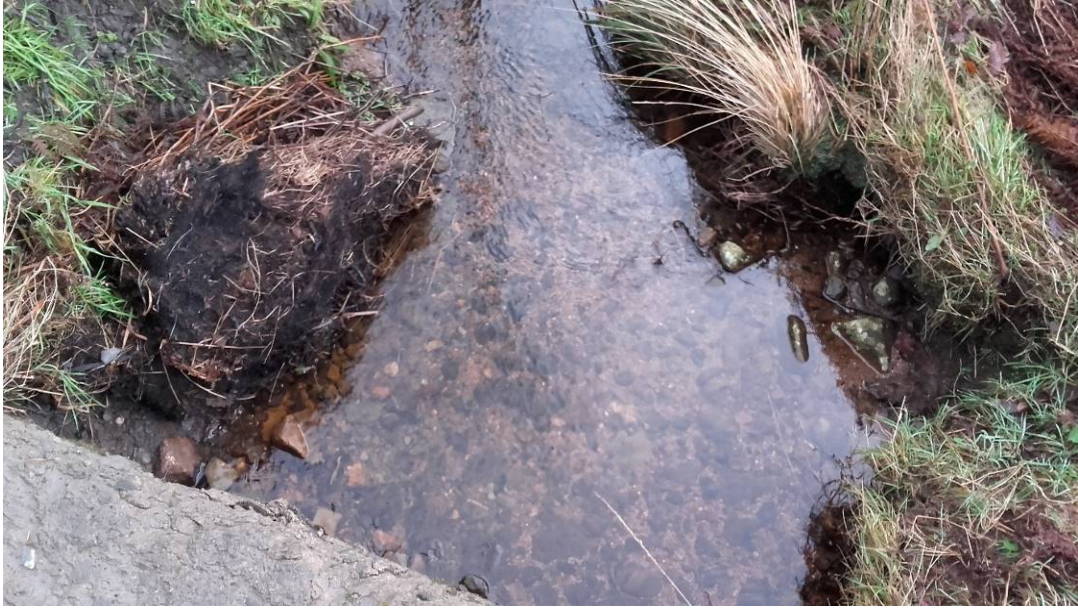
Figure 41: Another example of gravel filled burns which flow into the river which may be important areas of trout spawning and gravel addition into the main river (NX 260323 573374)

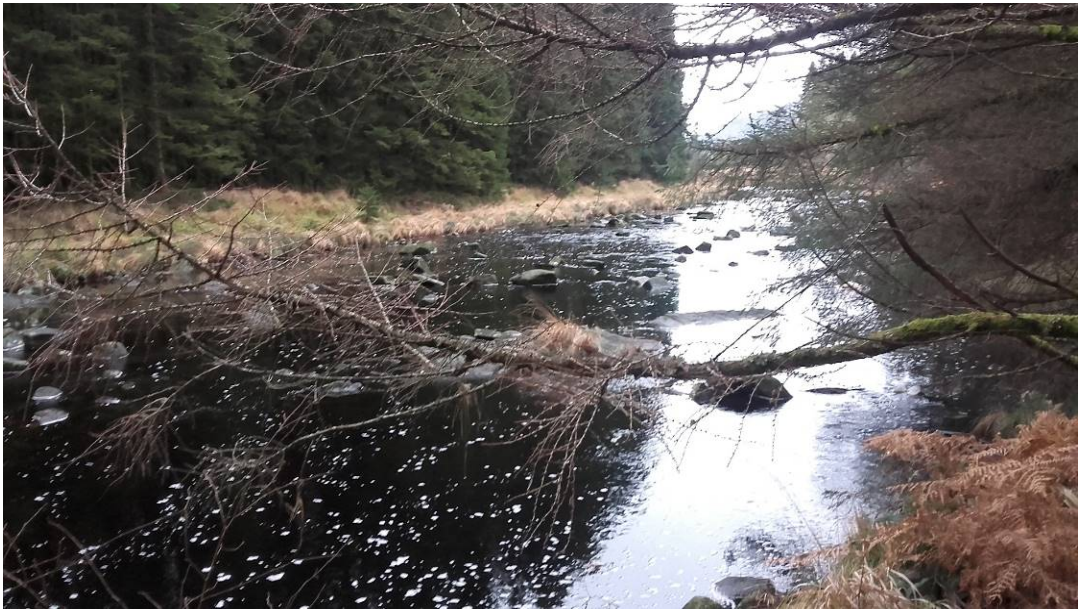
Figure 42: Riffle-run area enclosed by conifer plantations on both banks at (NX 260427 573317)

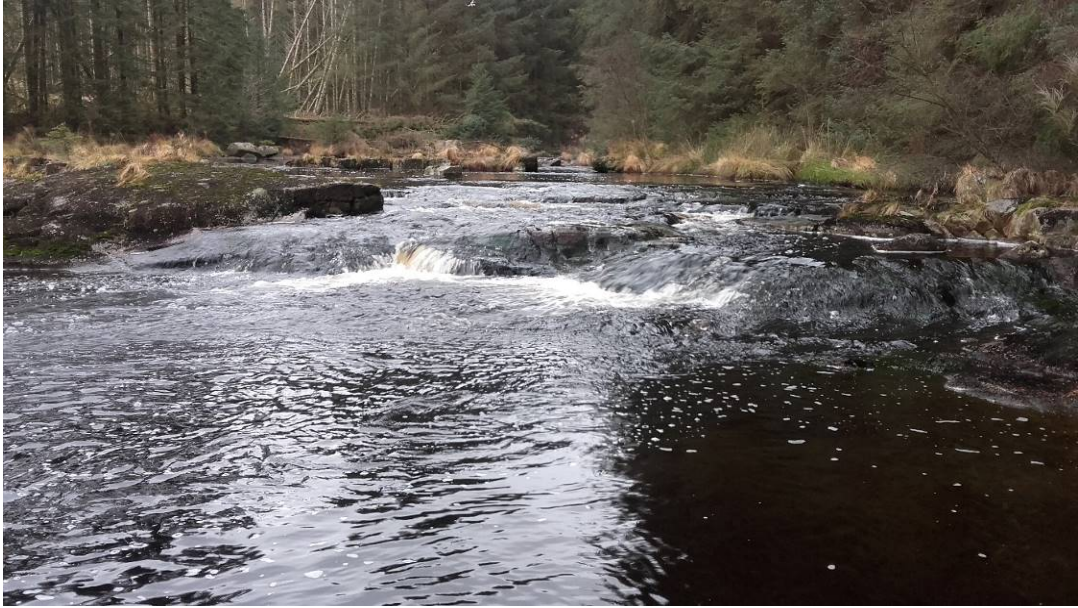
Figure 43: Difficult falls for fish access found at (NX 260604 573268), falls are quite steep with a bedrock substrate

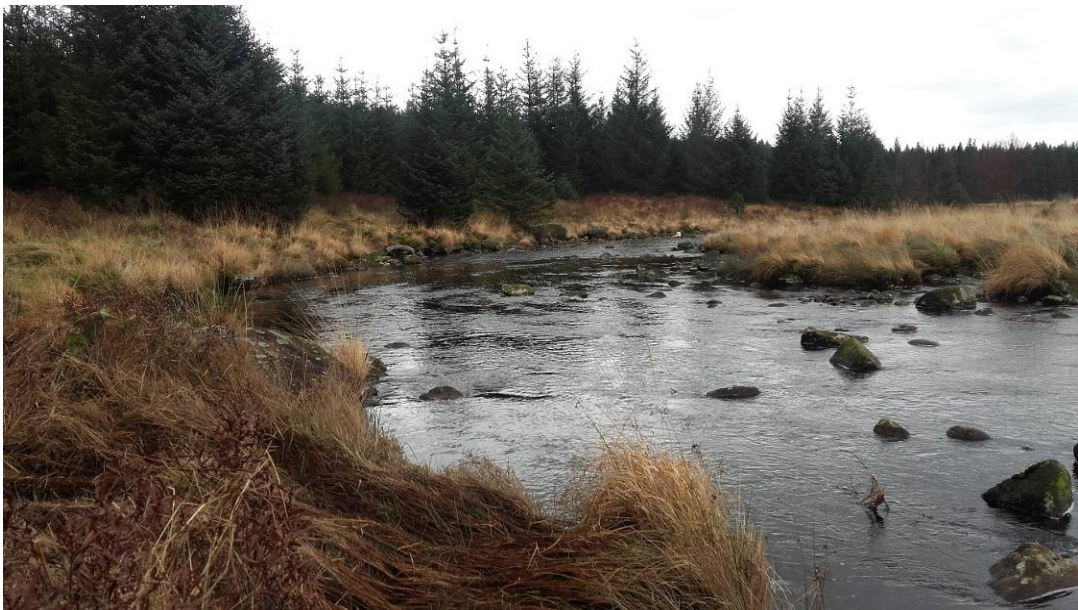
Figure 44: Mixed habitat of run-riffle with boulder and cobble substrate. Conifer plantation on the left bank, right bank may be suitable to future deciduous planting (NX 260738 573261)

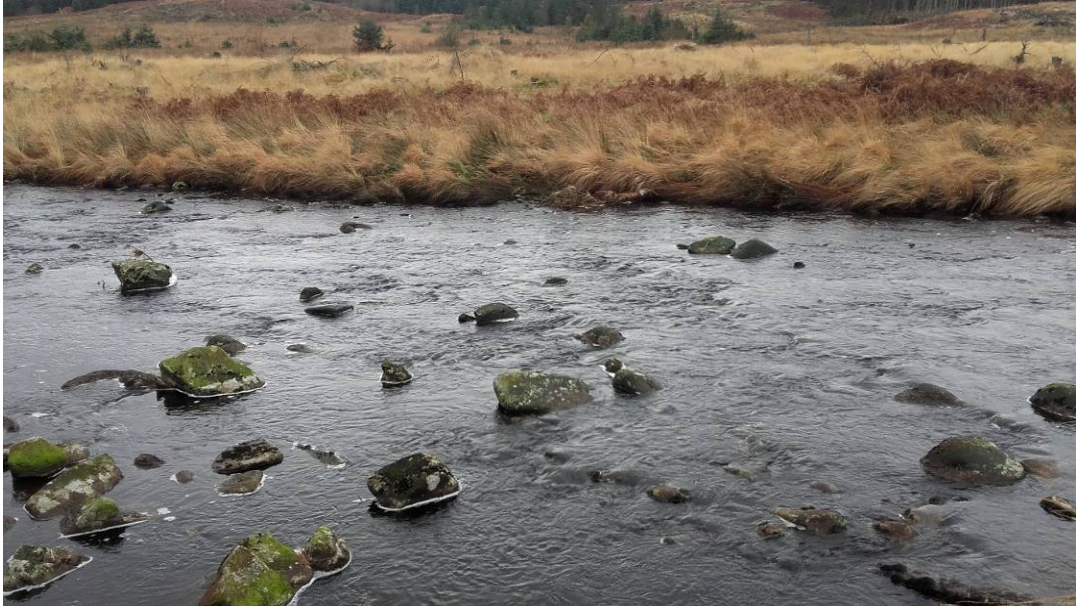
Figure 45: Example of run-riffle habitat found at (NX 260779 573256) which seems to have potential for being fry habitat however contains very little small substrate

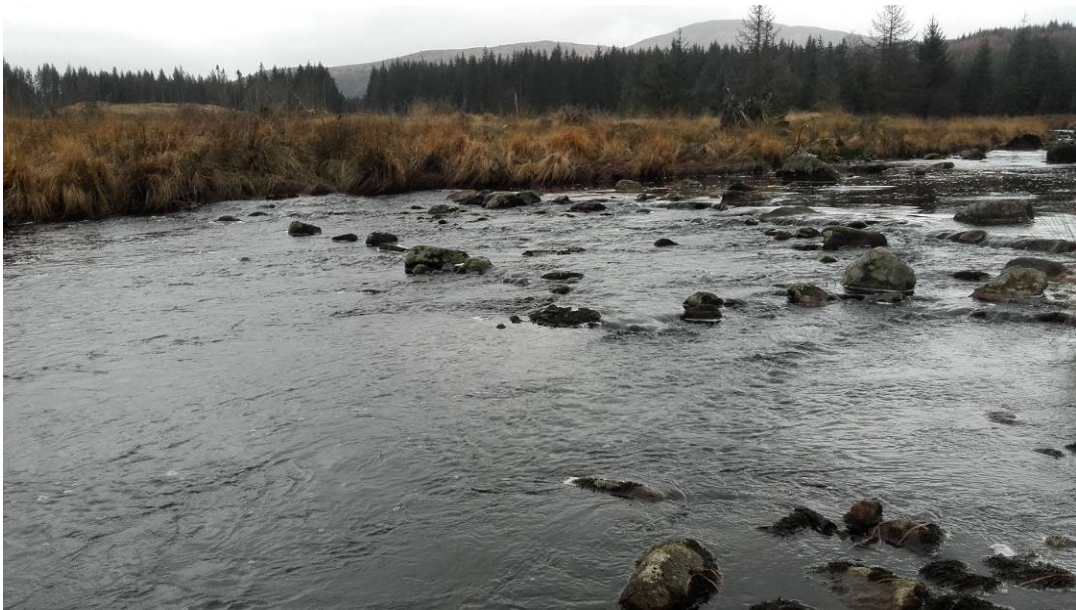
Figure 46: End point at 'ford', mixed habitat with cobble and boulder substrate at (NX 261059 573012)

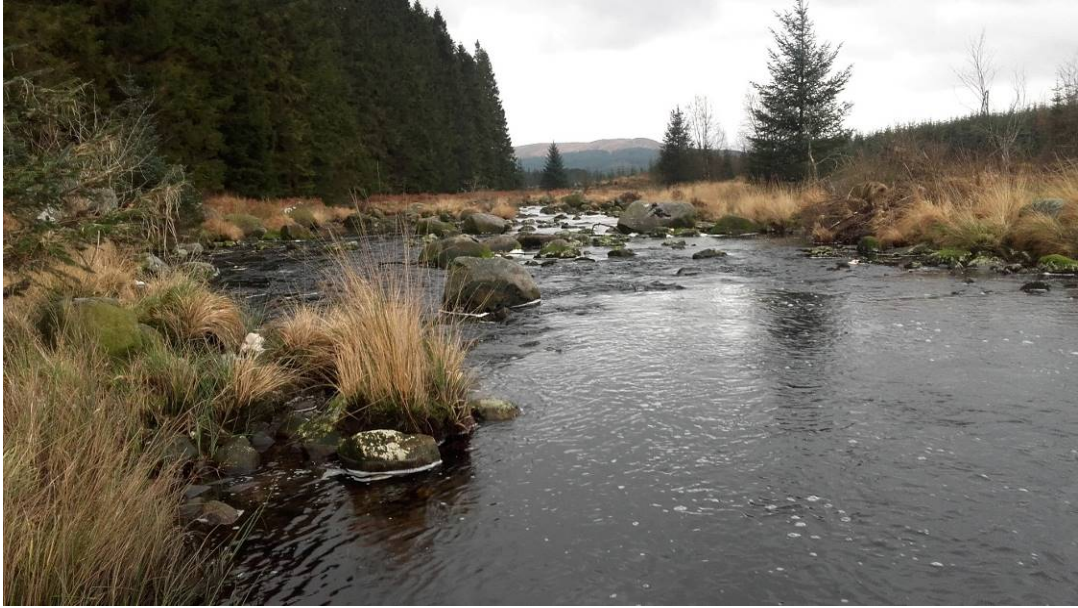
Figure 47: Parr habitat found directly below the ford with boulder substrate, conifer plantation on the left bank and natural regeneration of conifers on the right bank (NX 261093 572933)

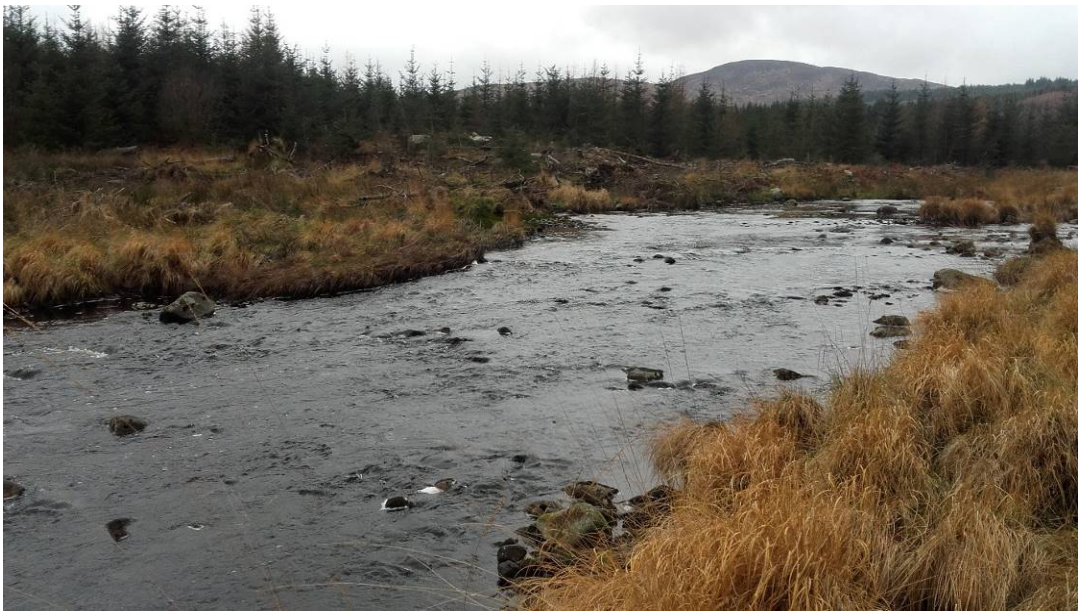
Figure 48: Good mixed habitat section with fry habitat nearby, conifer plantation can also be seen in the background (NX 261109 572788)

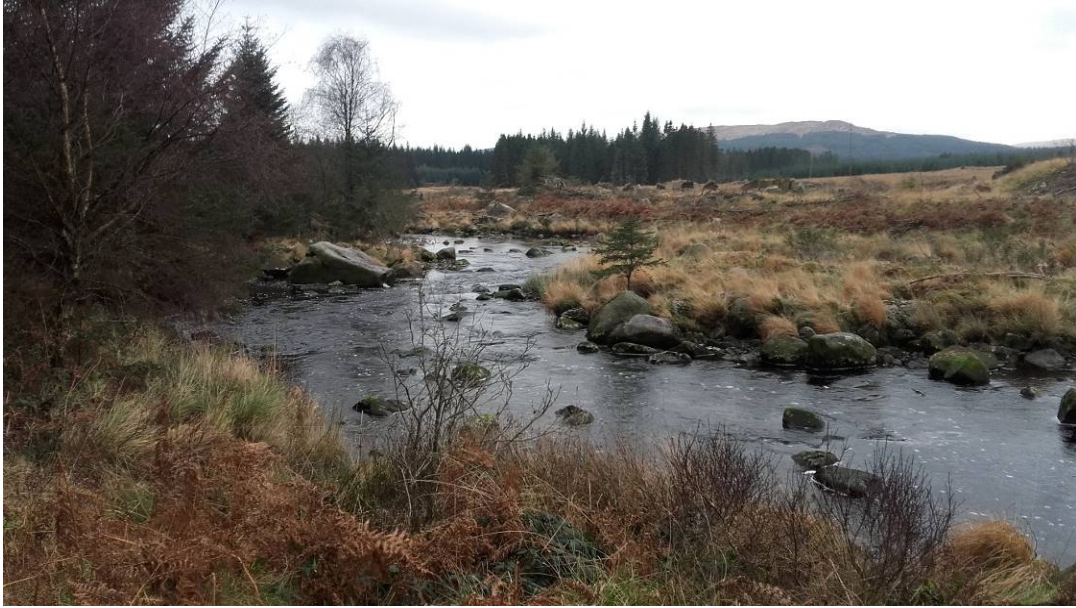
Figure 49: Example of the parr habitat found within this section with boulder and cobble substrate and naturally regenerating conifers. Suitable area on the right bank for deciduous tree planting (NX 261168 572774)

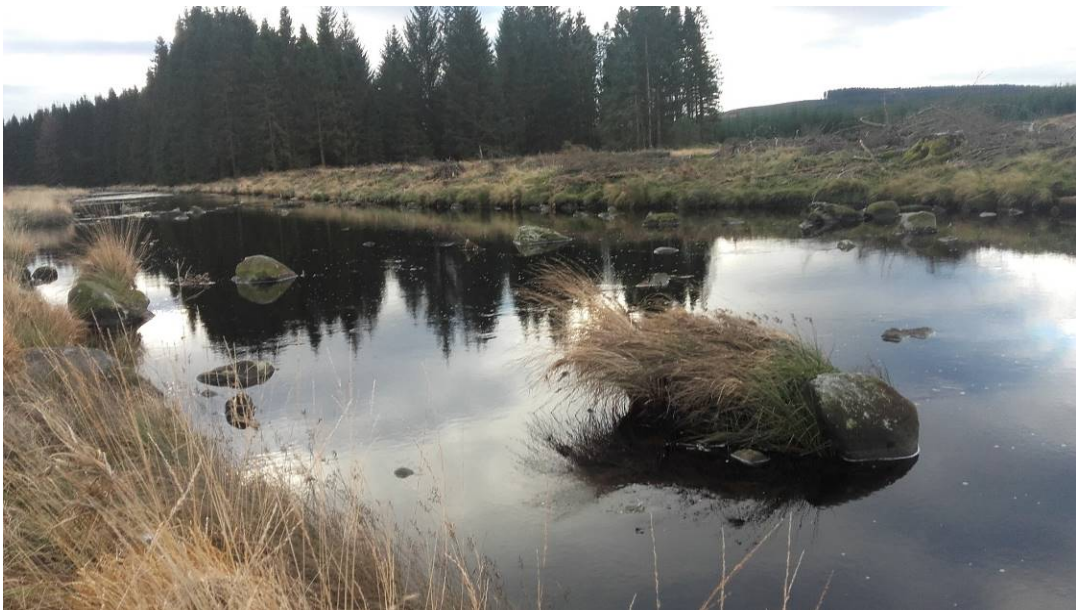
Figure 50: Glide habitat found at NX 261372 572528, conifer plantation is clearly seen on the right bank within 20 m of the bankside

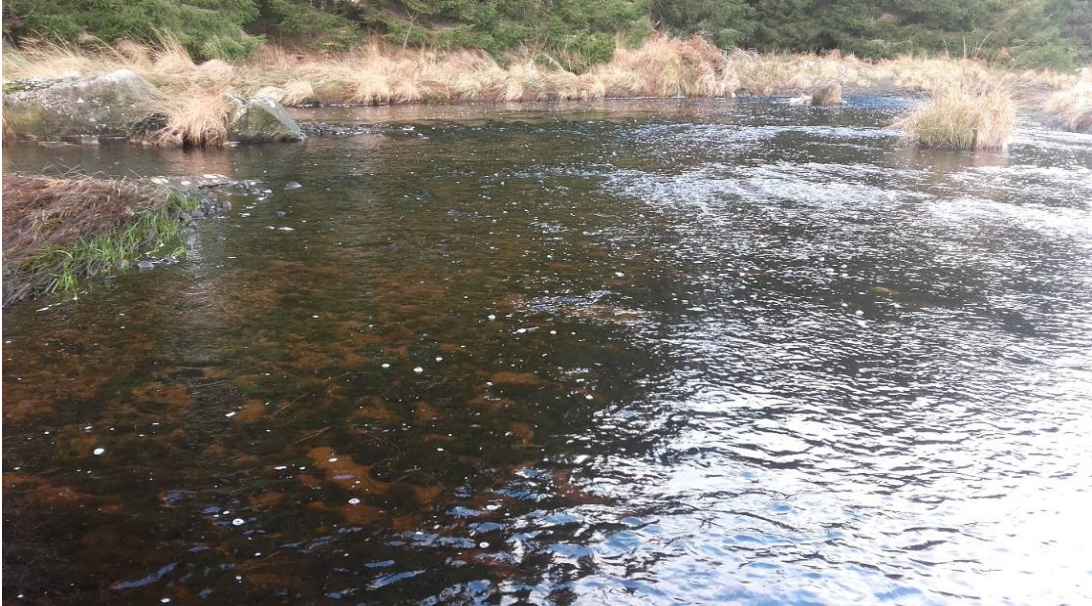
Figure 51: Shallow flows over cobble and gravel substrate at (NX 261476 572219), suitable spawning site and fry habitat. Conifer plantation can be seen close to right bank in background

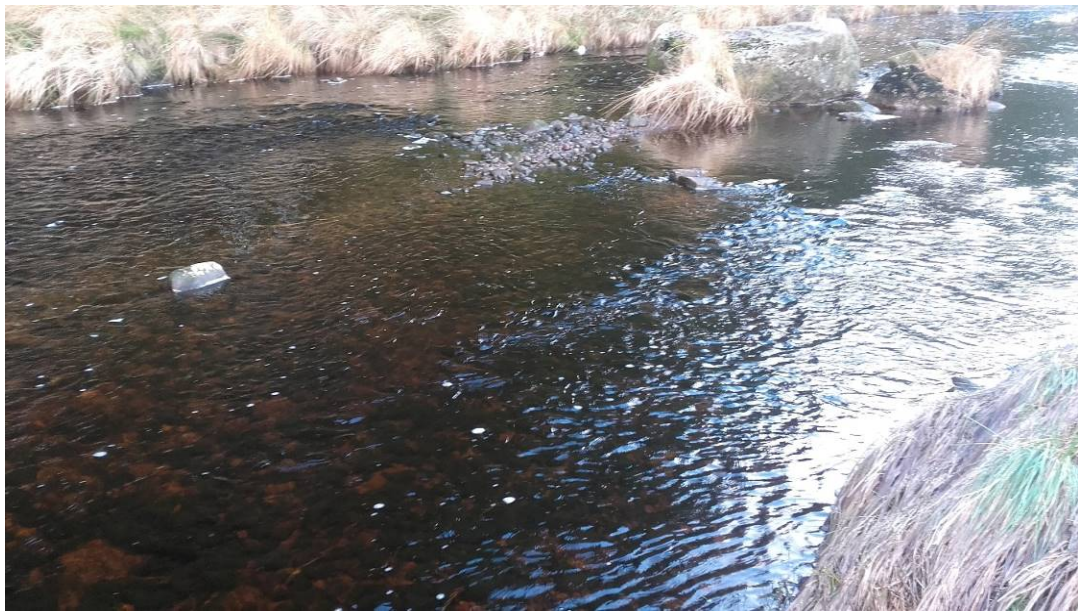
Figure 52: Shallow flows over cobble and gravel substrate at (NX 261476 572219), suitable spawning site and fry habitat

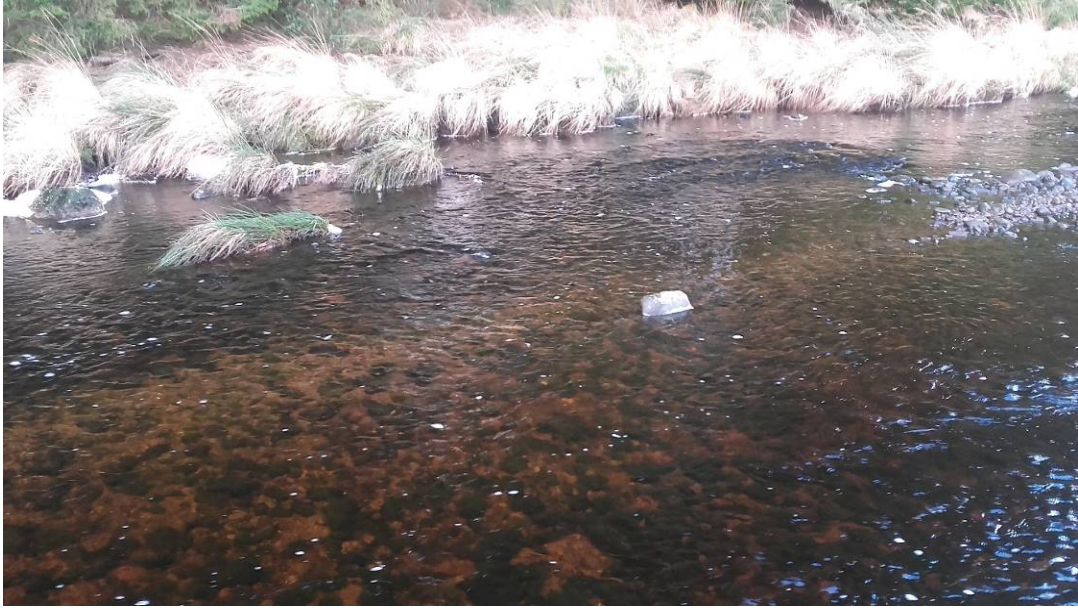
Figure 53: Shallow flows over cobble and gravel substrate at (NX 261476 572219), suitable spawning site and fry habitat

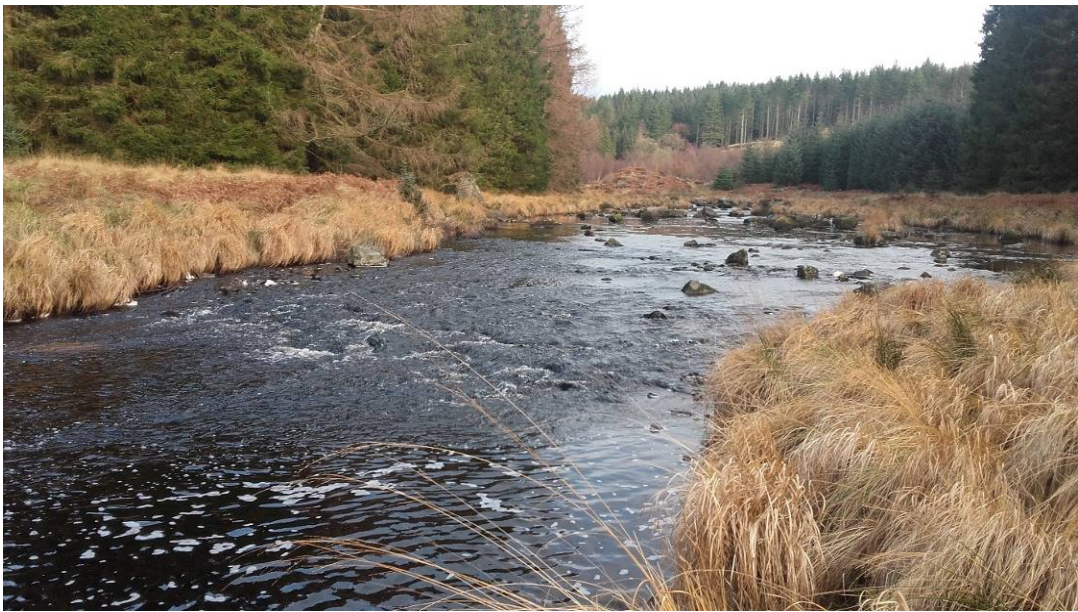
Figure 54: Mixed habitat section with conifer plantations recorded on both banks (NX 261535 572083)

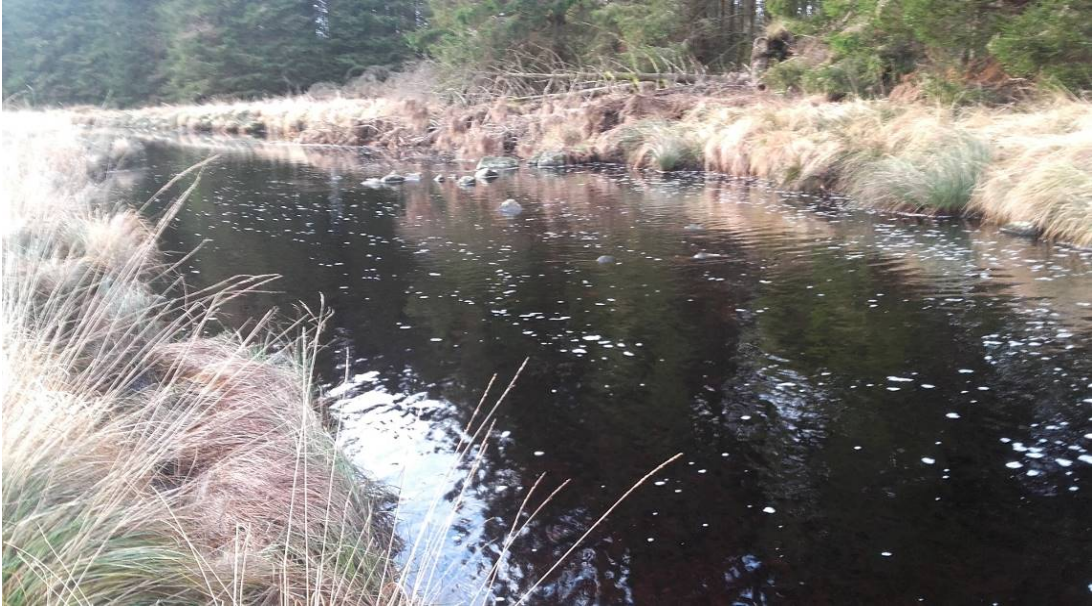
Figure 55: A return to glide habitat with a conifer plantation visible on the right bank (NX 261535 572083)

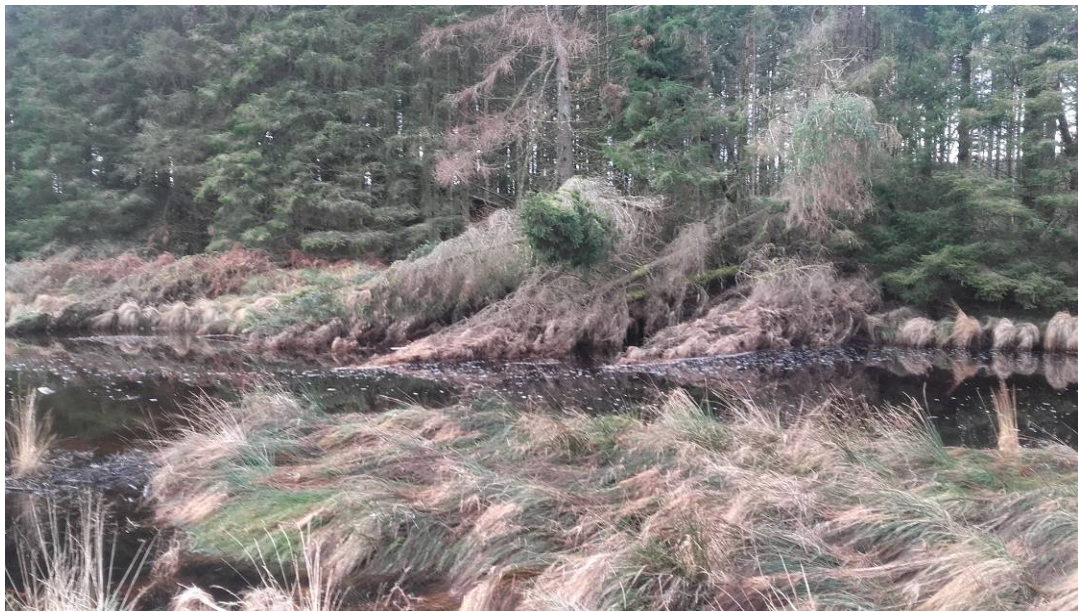
Figure 56: Example of fallen conifers at NX 261477 571899, this should be addressed

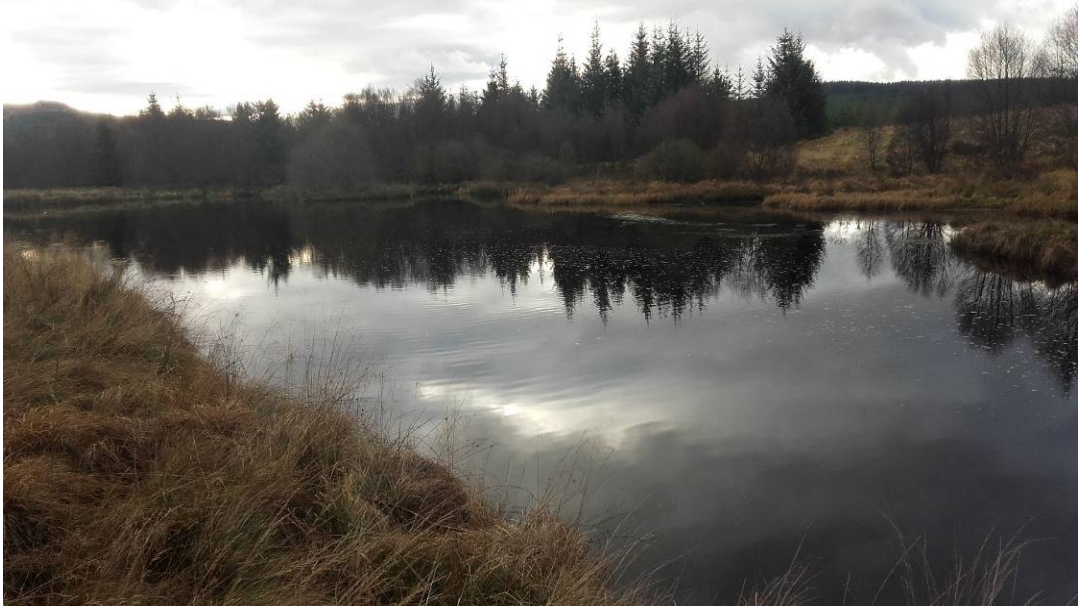
Figure 57: River widens considerably with glide habitat (NX 261534 571763)

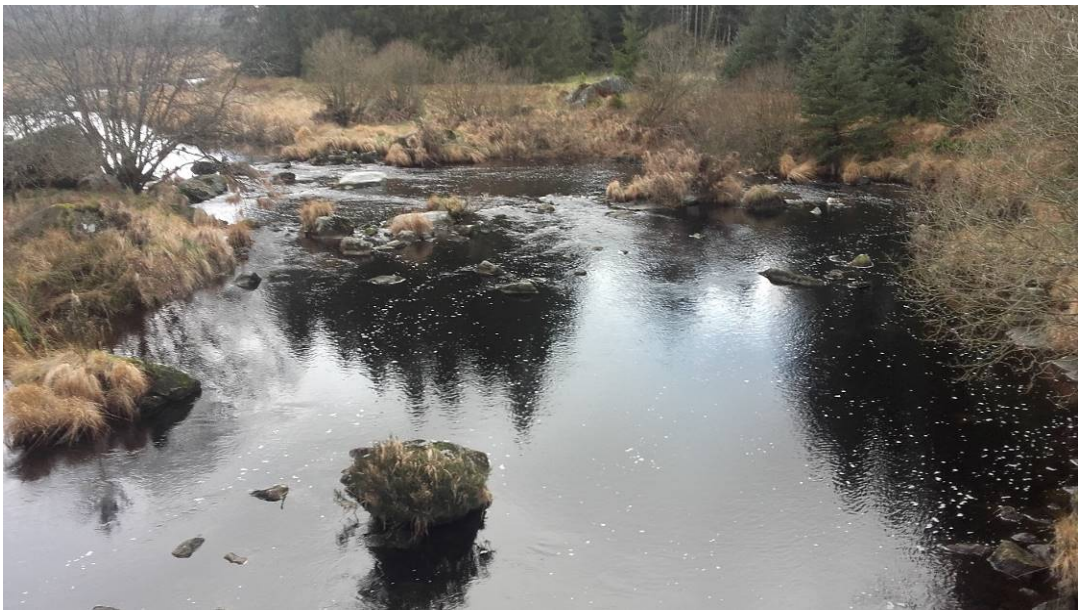
Figure 58: Picture of the upstream view from Barney bridge, parr habitat was found to dominate this area with a mix of deciduous and coniferous trees on both banks (NX 261870 571460)

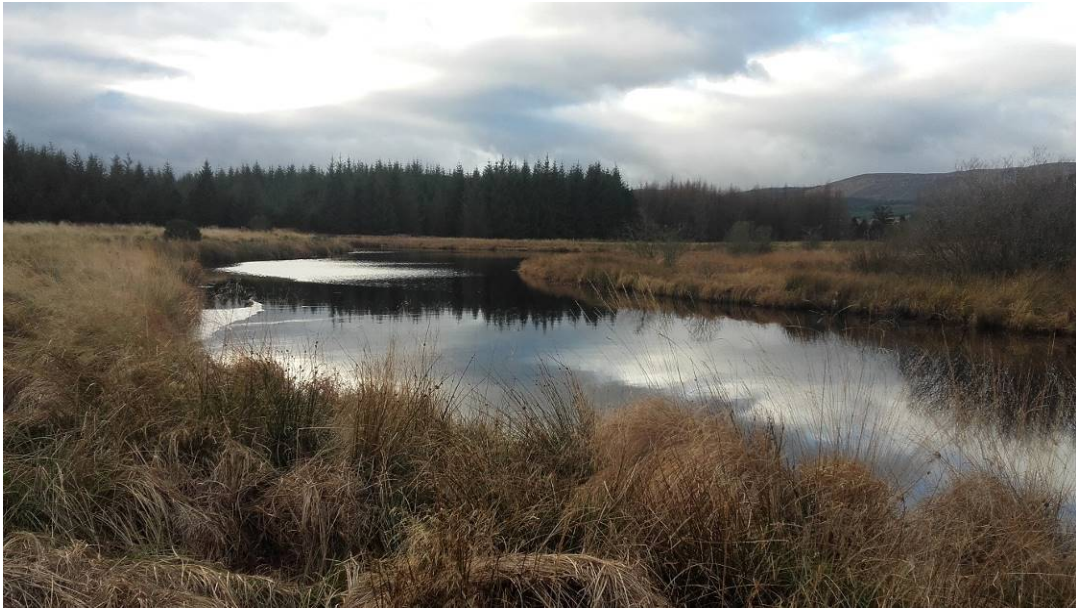
Figure 59: Glide habitat found downstream of Barney Bridge at NX 262036 571346

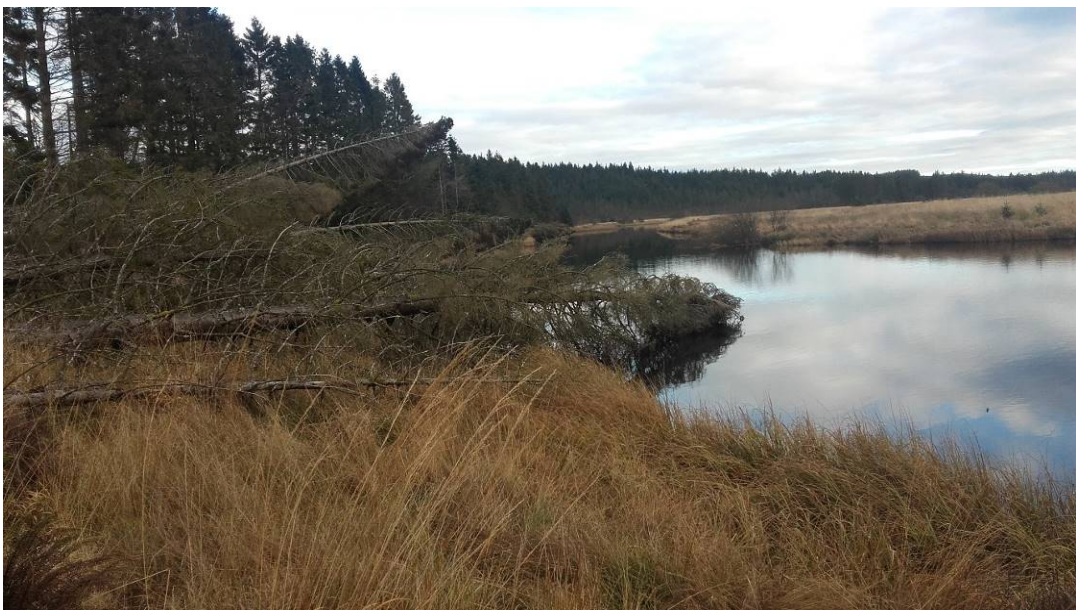
Figure 60: Windblown conifers found lying in the river at NX 262429 570552

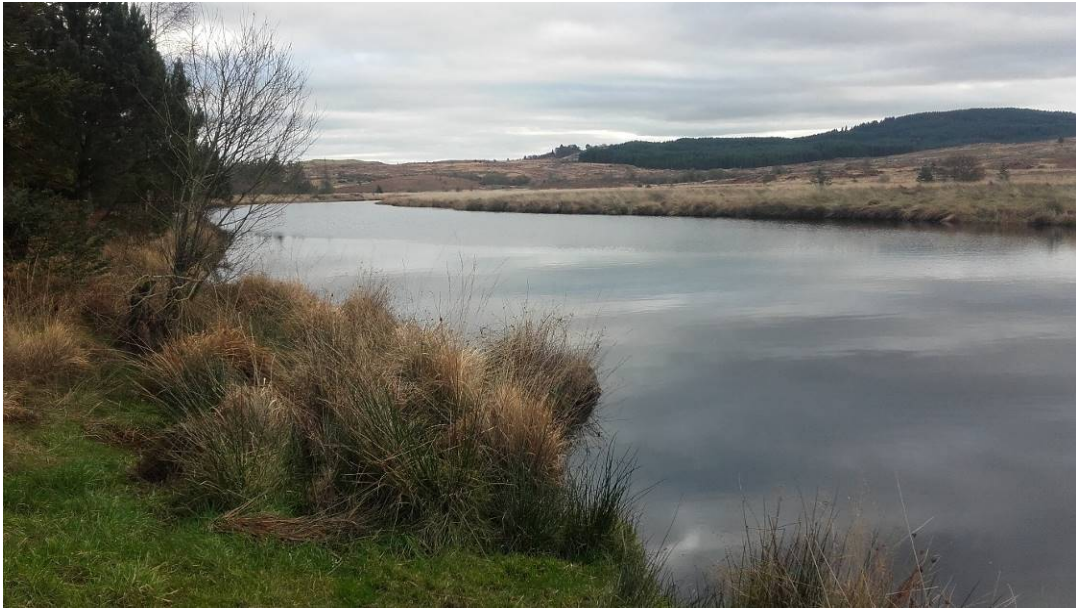
Figure 61: Deep glide section at 'Bodens island', conifer plantation on the left bank (NX 263485 570907)

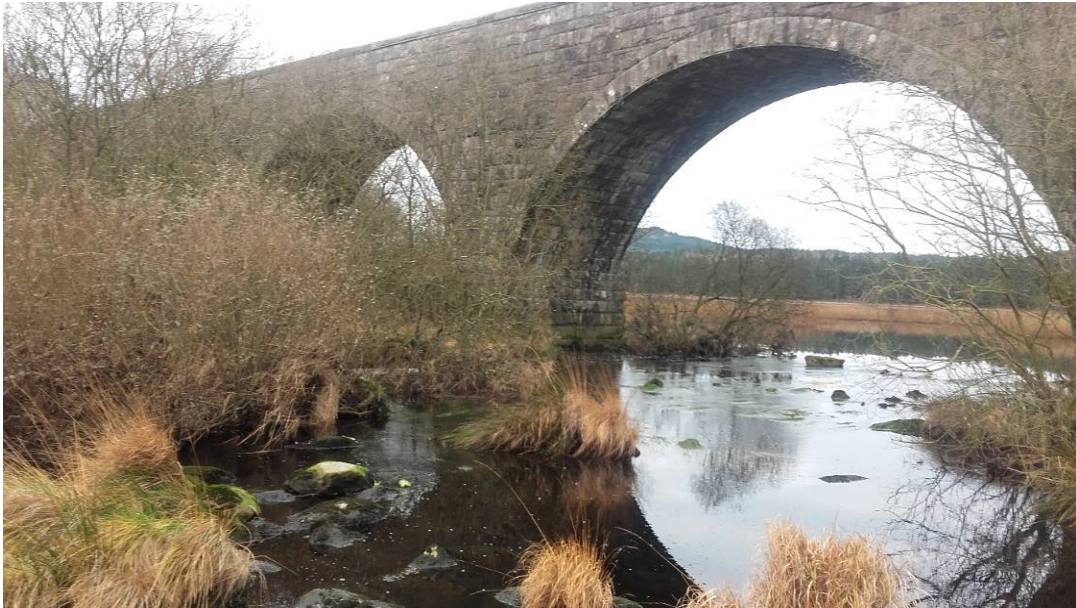
Figure 63: Start of survey at the bottom of Stroan Loch (NX 264701 569972)

At the beginning of this section run-riffle and glide habitats were found downstream of the bridge at NX 264701 569972 (Figures 63 and 64). Numerous deciduous trees were present on the banks with bedrock and boulder the dominant substrate. An area of bedrock falls was recorded immediately downstream at NX 264769 569885, this section of falls may be an obstruction to fish migrating upstream, under normal flows, to Stroan Loch (Figures 65 and 66). Naturally regenerating conifers were also found (Figures 64 and 66). Downstream there was a return to parr habitat with boulder substrate and a mix of run-riffle with some glide habitat (Figures 67, 68 and 69). Deciduous trees became quite abundant at this section and can be clearly seen in Figures 67, 68, 69 and 70.

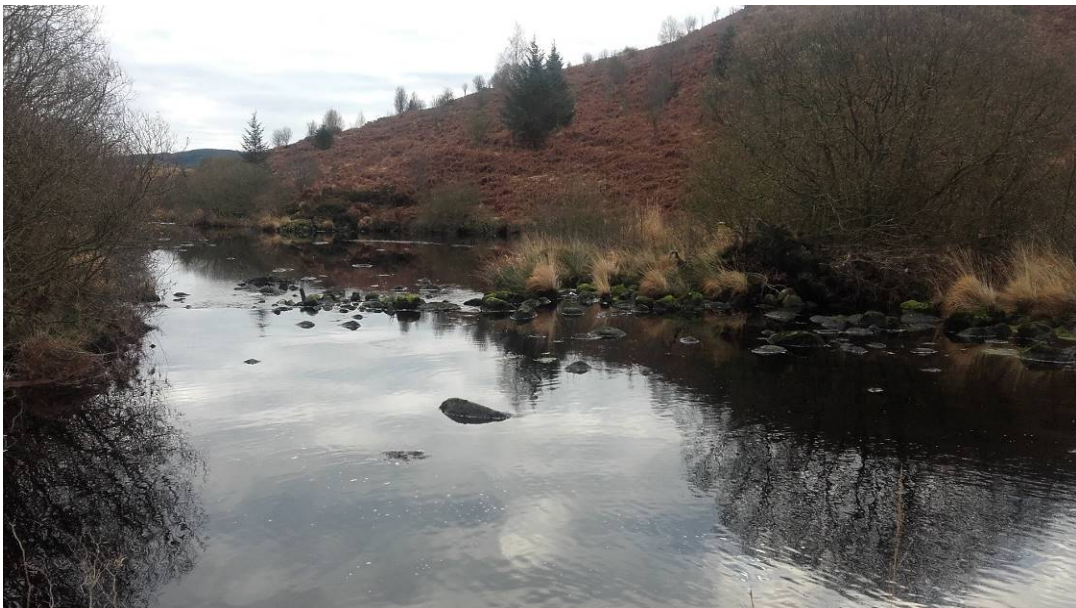
Figure 64: Parr habitat area with boulder substrate and riparian deciduous trees and naturally regenerating conifers (NX 264701 569972)

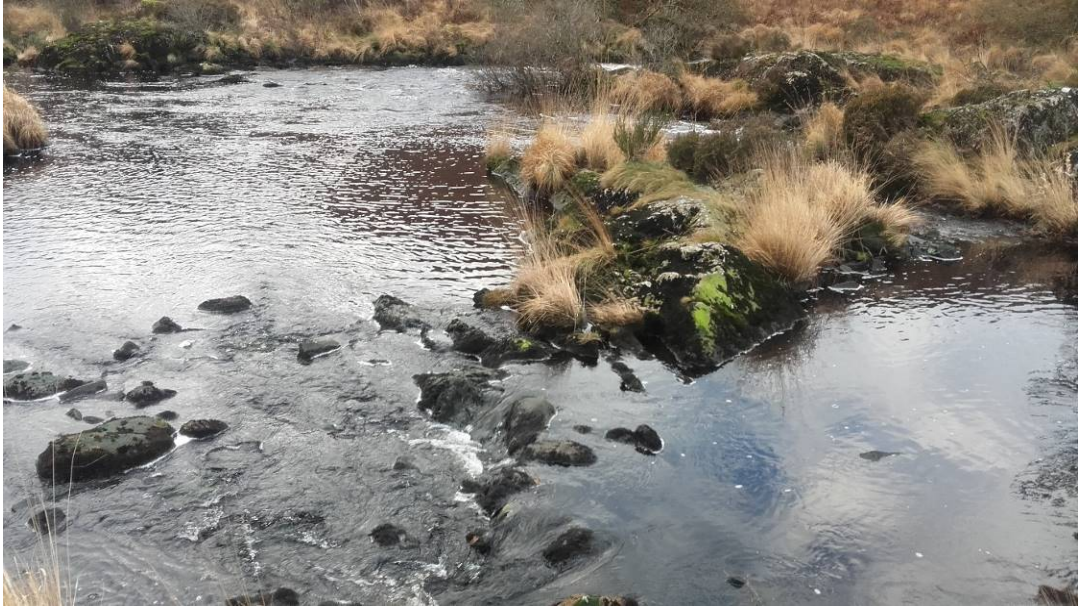
Figure 65: Falls section with bedrock and boulder substrate, this may cause an obstruction to fish migration under normal compensation flows (NX 264769 569885)

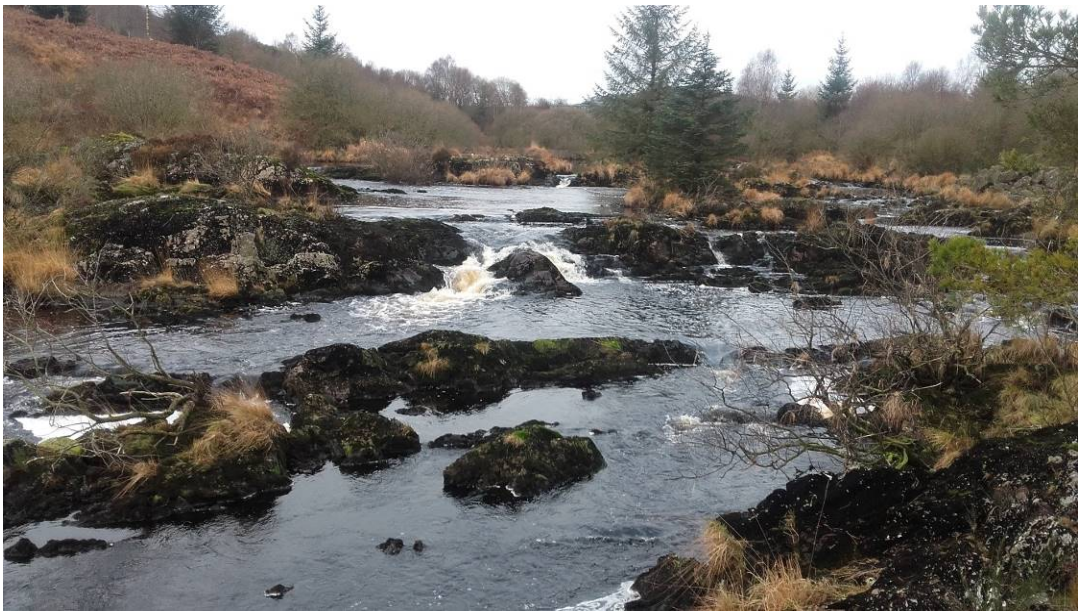
Figure 66: Another view of the falls section from Figure 65, some naturally regenerating conifers are visible along with the bedrock substrate (NX 264769 569885)

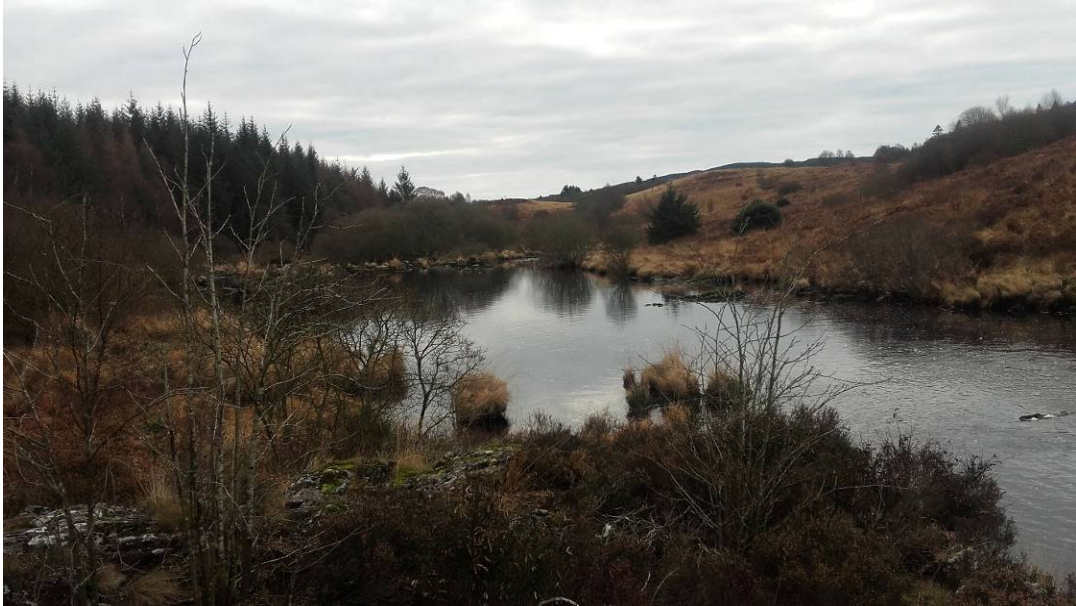
Figure 67: Glide section with some run habitat found at NX 264769 569885, both riparian deciduous trees and conifers can be seen here. The right bank may be suitable for further riparian deciduous planting
