Commissioned Report No. – JRAD0416

Black Water of Dee fisheries and habitat study

Contractor: Scottish Power

Year of publication: January 2017

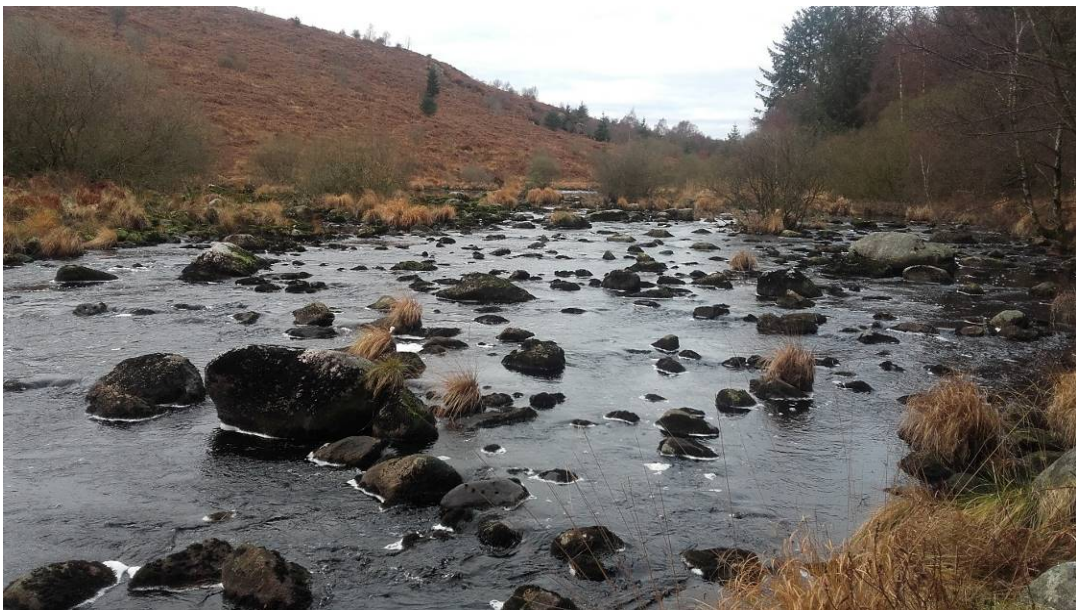
Figure 68: Parr habitat with boulder substrate and riparian deciduous trees on the left bank, the right bank was relatively treeless and may be a suitable site for future planting (NX 264881 569764)

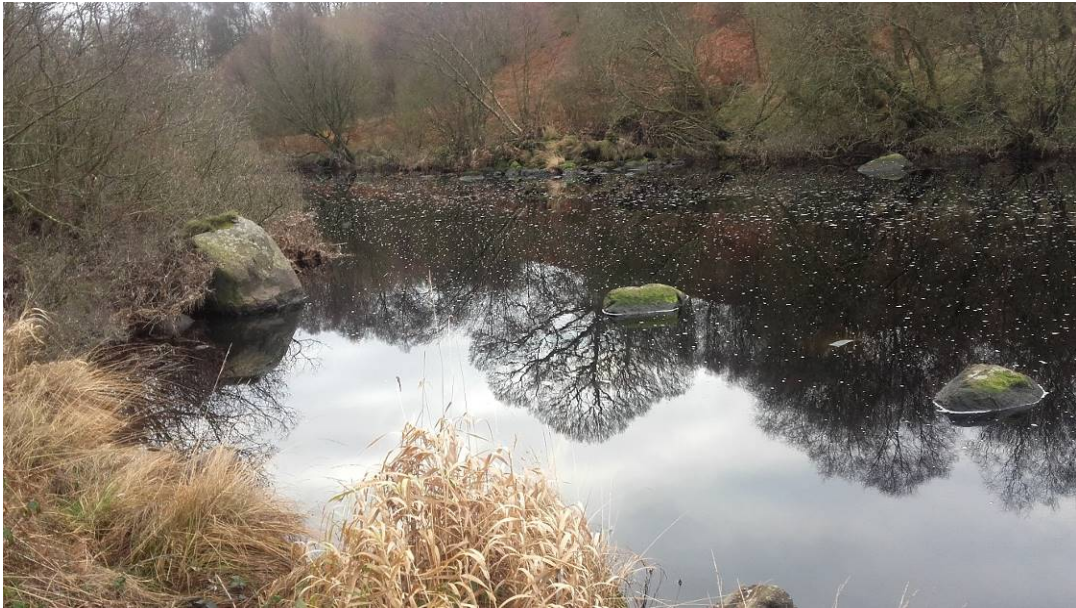
Figure 69: Glide section at NX 265039 569468, riparian deciduous trees were numerous along this section

At the beginning of this section run-riffle and glide habitats were found downstream of the bridge at NX 264701 569972 (Figures 63 and 64). Numerous deciduous trees were present on the banks with bedrock and boulder the dominant substrate. An area of bedrock falls was recorded immediately downstream at NX 264769 569885, this section of falls may be an obstruction to fish migrating upstream, under normal flows, to Stroan Loch (Figures 65 and 66). Naturally regenerating conifers were also found (Figures 64 and 66). Downstream there was a return to parr habitat with boulder substrate and a mix of run-riffle with some glide habitat (Figures 67, 68 and 69). Deciduous trees became quite abundant at this section and can be clearly seen in Figures 67, 68, 69 and 70.

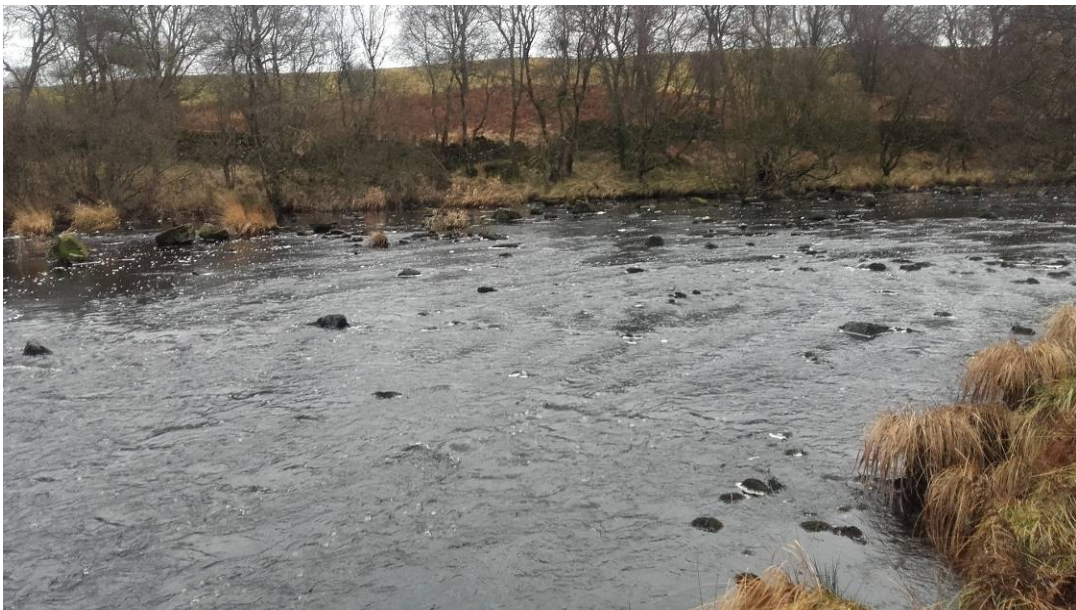
Figure 70: Mixed habitat with cobble and boulder substrate, riparian deciduous trees were abundant on the right bank (NX 265401 569310)

Parr habitat continued downstream with a mix of run-riffle and glide being recorded. Mixed habitat was recorded at NX 265401 569310 with run-riffle flows and boulder and cobble substrate (Figure 70). A section of bedrock and boulder falls was then recorded at NX 265577 569596. These falls did not appear to cause a definite obstruction to fish moving upstream, however they occurred in a series of steps (seen in Figure 71) which may make migration difficult for fish. Once again riparian deciduous trees were plentiful on the right-hand bank (Figure 71), the left bank was found to be relatively treeless and could be a suitable location for deciduous planting. A glide section located downstream had treeless banks on both sides (Figure 72).

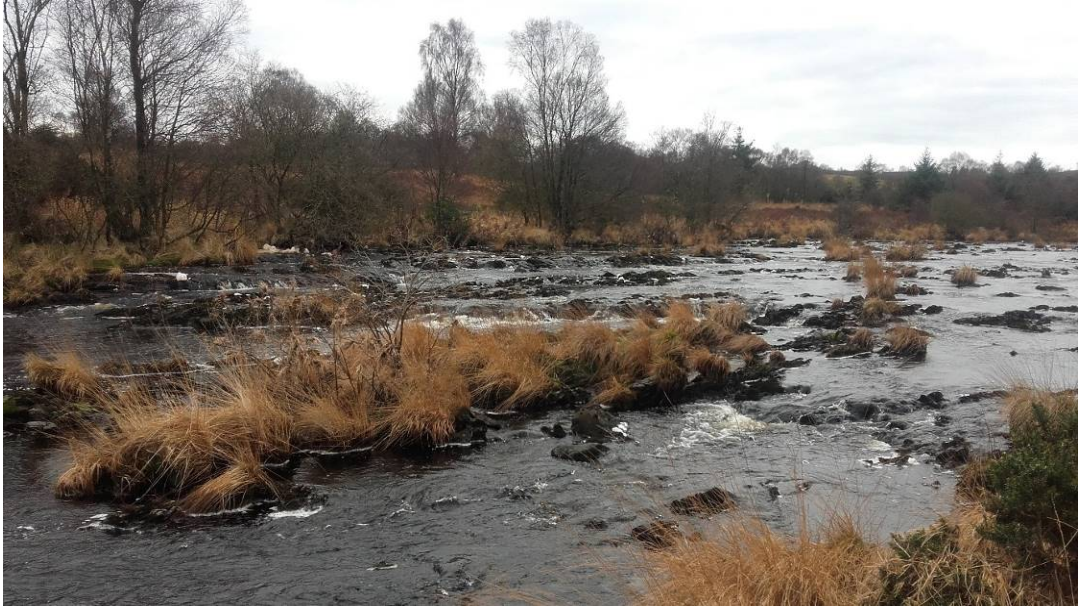
Figure 71: Small bedrock falls at NX 265577 569596, the stepped nature of these falls may make upstream migration difficult in normal flows

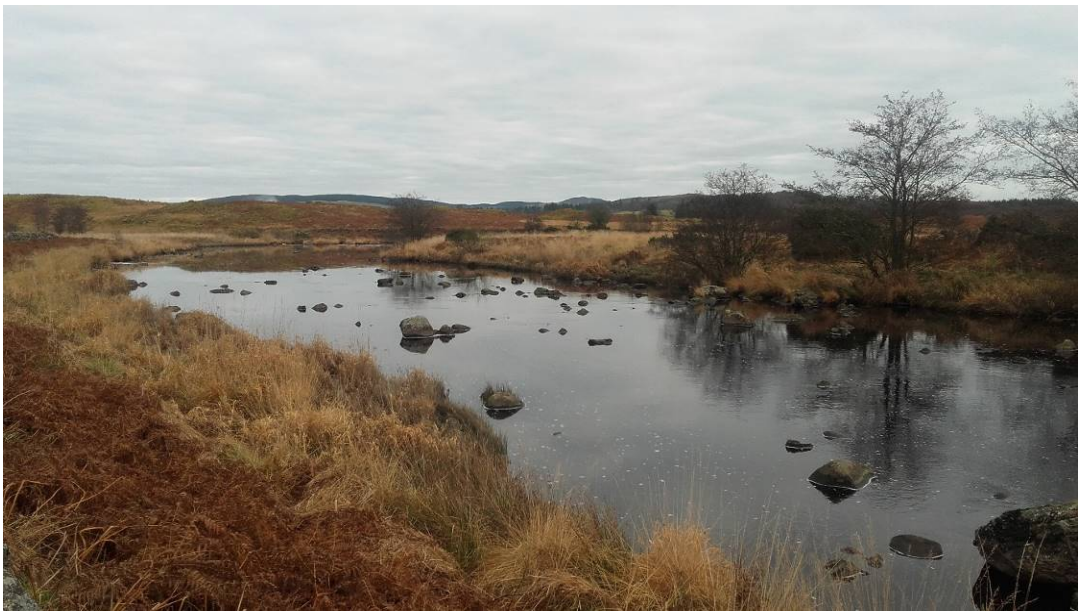
Figure 72: Glide section with a treeless left bank (NX 265628 569718)

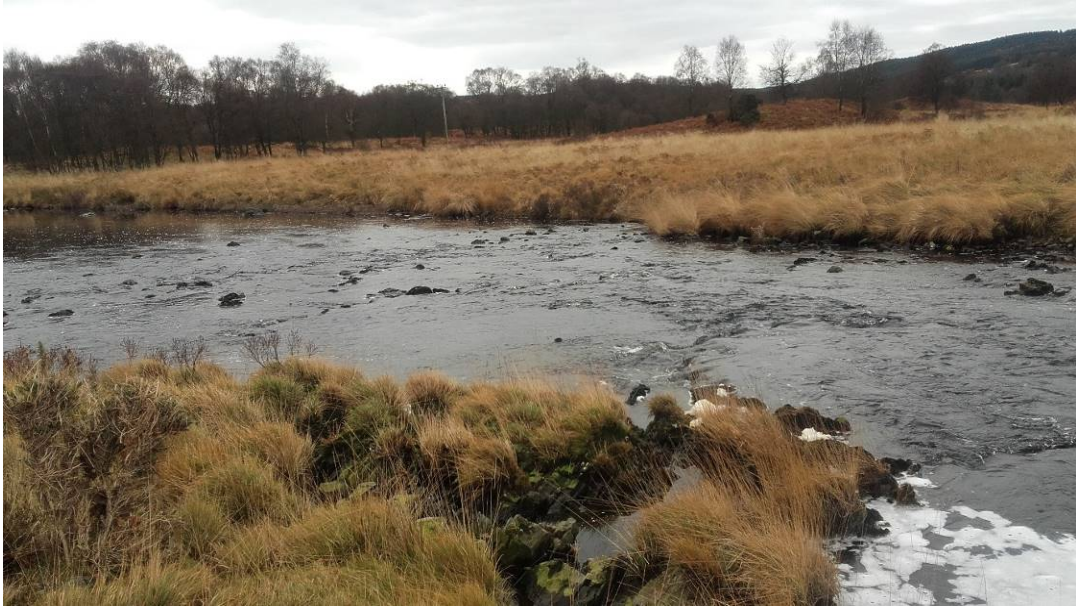
Figure 73: Area of mixed habitat with boulder and cobble substrate, treeless banks were found here indicating that it may be a suitable site for planting deciduous trees (NX 265796 569853)

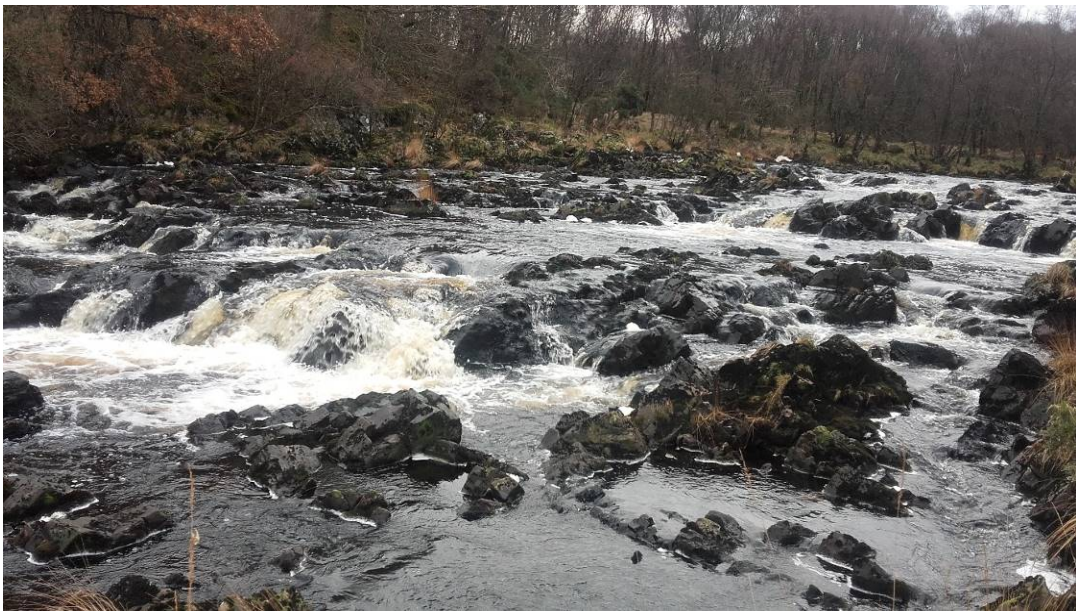
Figure 74: Steep bedrock falls at NX 265996 569811, these appear to cause a possible obstruction to migrating fish under normal compensation flows

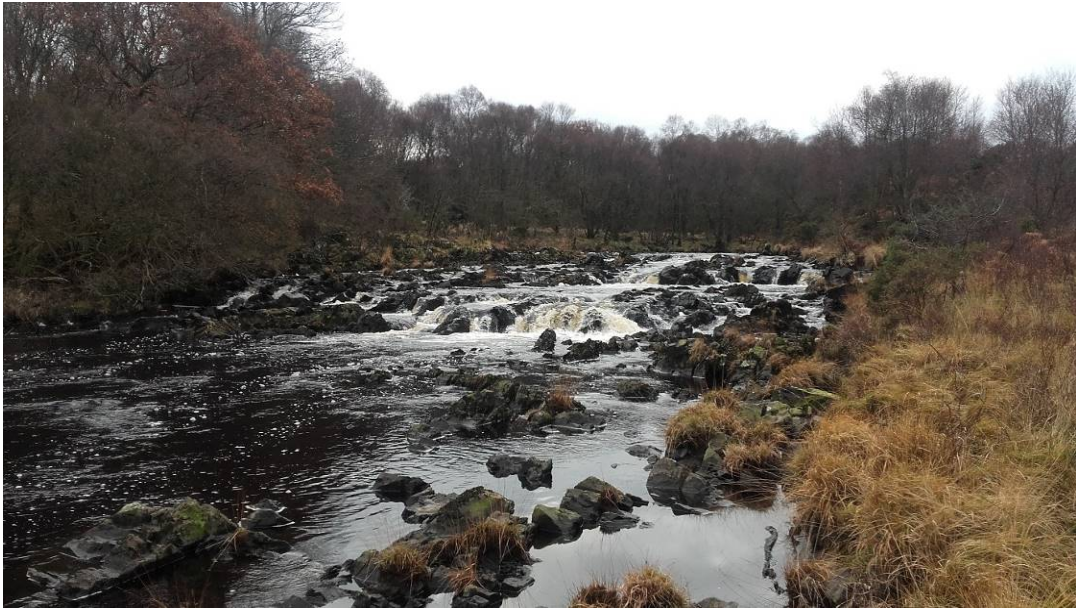
Figure 75: Steep falls from Figure 74, an abundance of riparian deciduous trees can be seen here (NX 265996 569811)

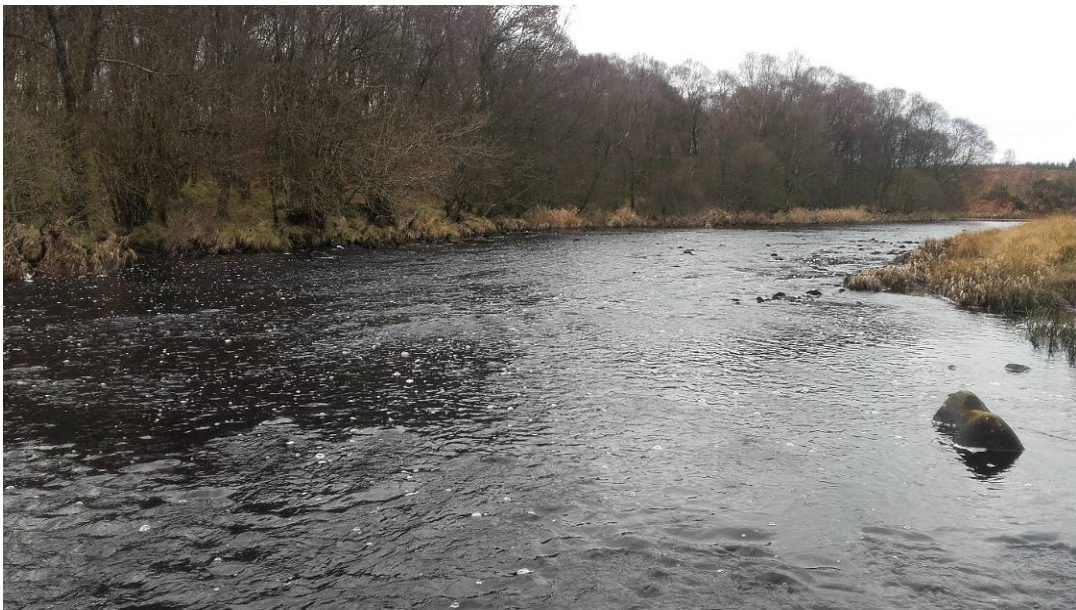
Figure 76: Run-riffle habitat with cobble and some boulder substrate, deciduous trees were abundant on the right bank with the left bank found to be treeless. This site has the potential to be good fry habitat if smaller substrate were more abundant (NX 266163 569826)

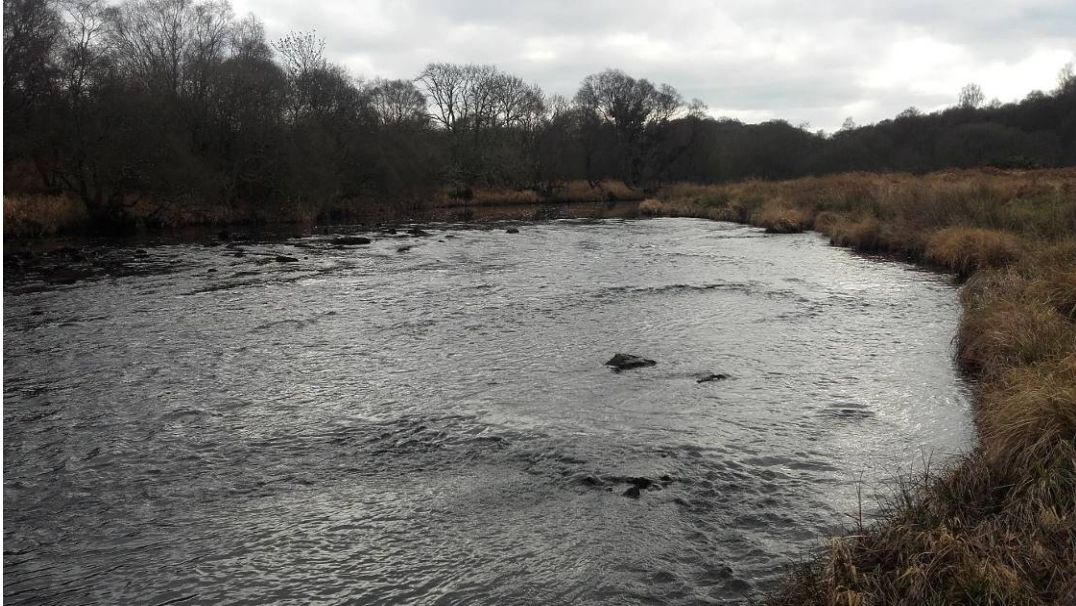
Figure 77: Run-riffle habitat with cobble and boulder substrate, this site has potential to be good fry habitat if smaller substrate were present (NX 266181 569942)

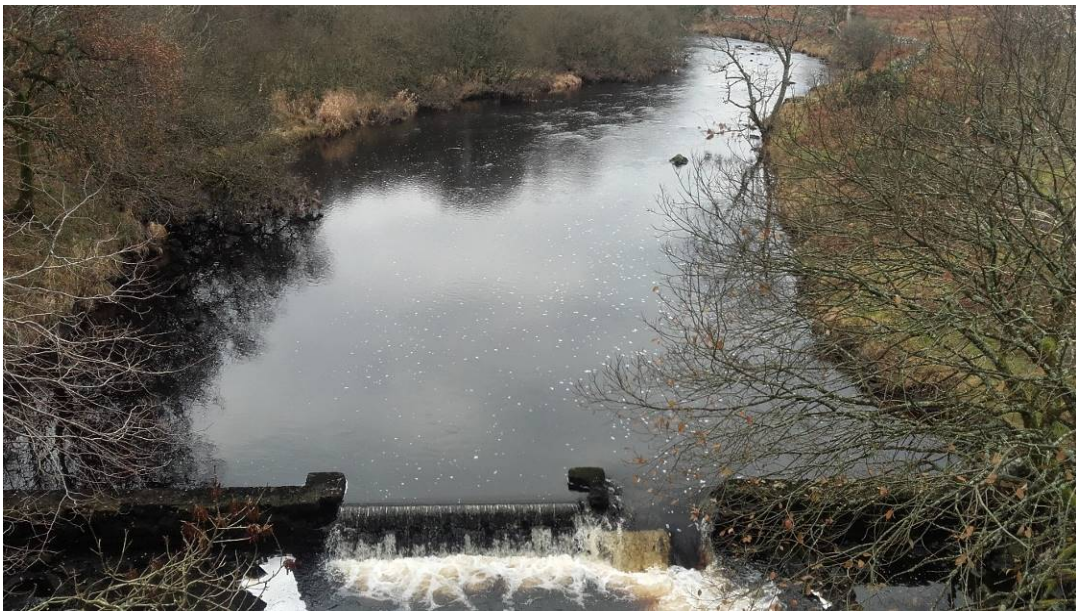
Figure 78: Hensol Weir located at NX 266364 570073, glide habitat was recorded upstream. The impact of this weir on fish migration and sediment transport should be investigated

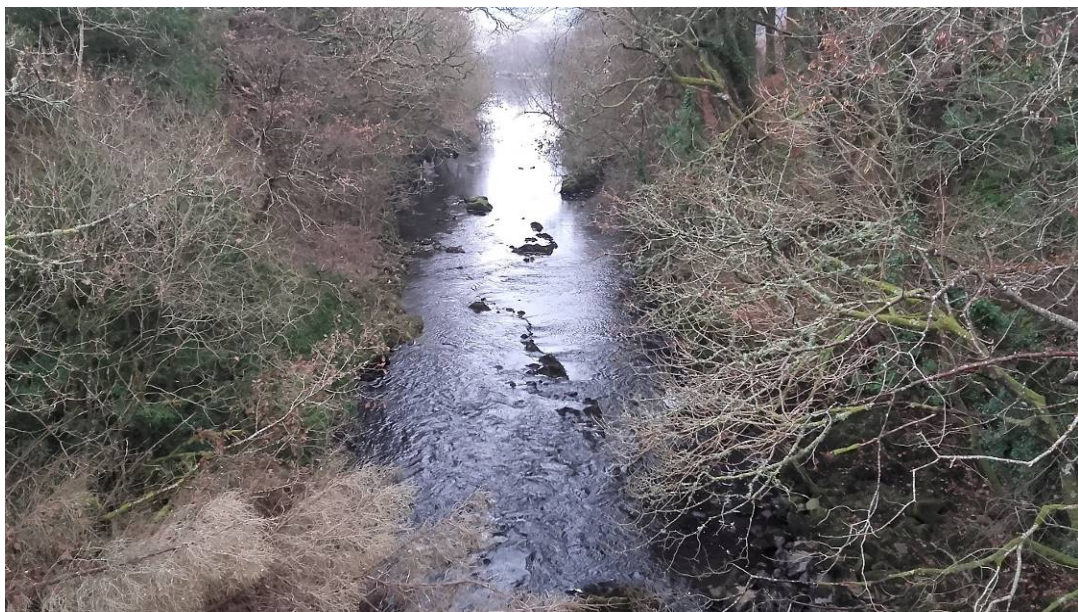
Figure 79: Parr habitat found just downstream of Hensol Bridge at NX 266364 570073. Riparian deciduous trees were abundant on both banks

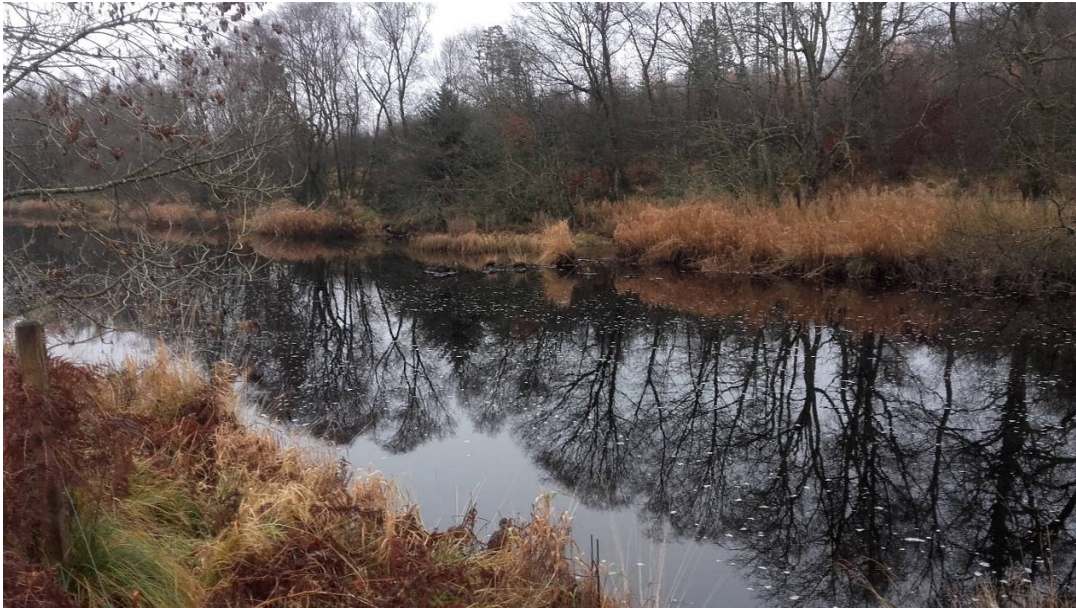
Figure 80: Deep glide habitat found at NX 266471 570179

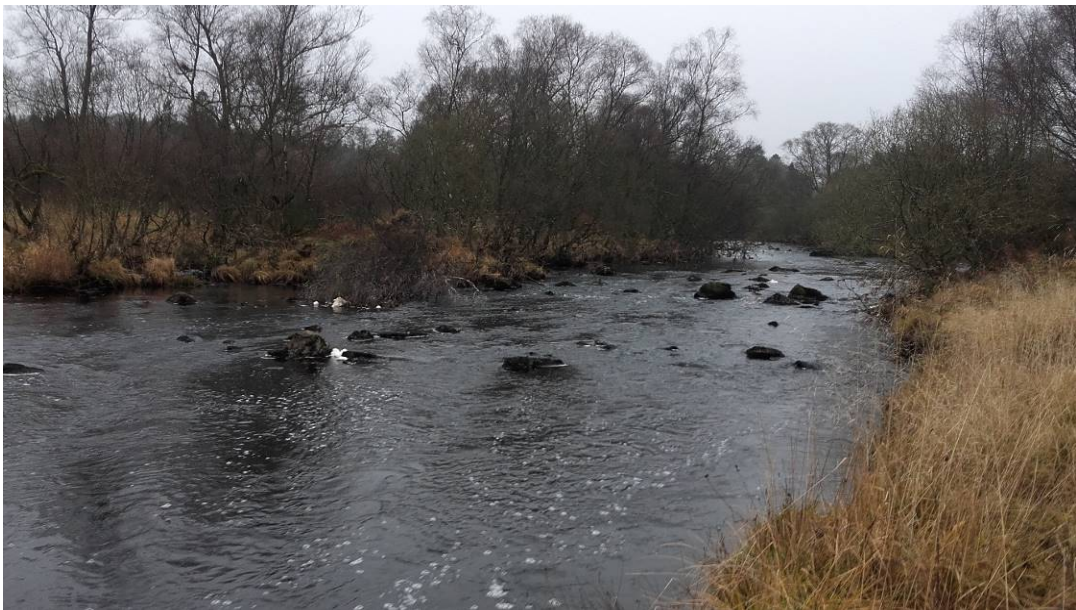
Figure 81: Mixed juvenile habitat area at (NX 266723 570375). Cobble, boulder, pebble and gravel substrates were all found here

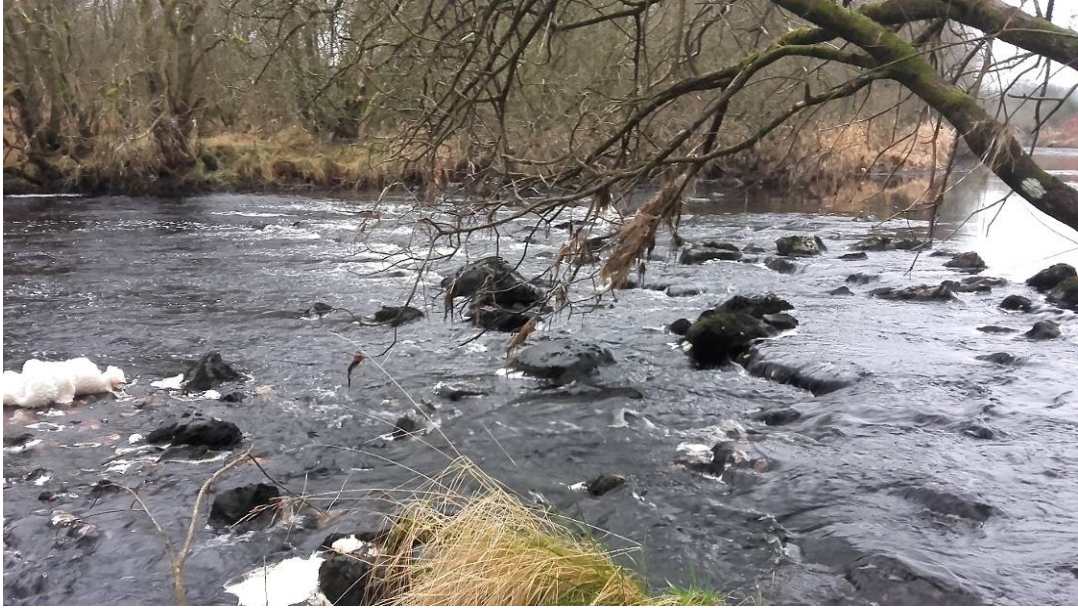
Figure 82: Small bedrock and boulder falls found just downstream of Figure 81

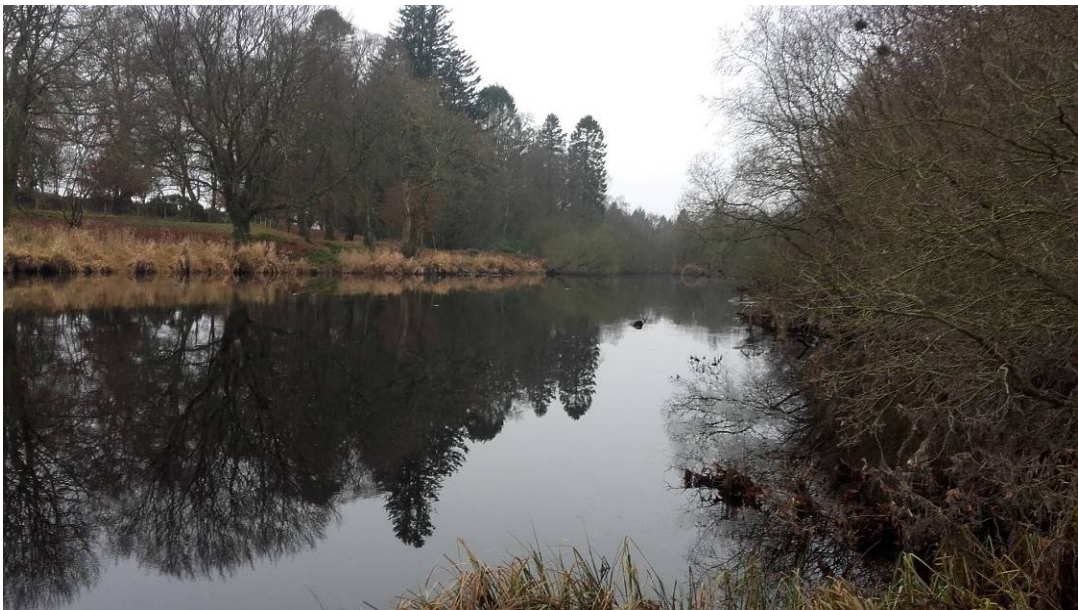
Figure 83: Area of deep glide found at (NX 267956 570076). Numerous deciduous trees were present on both banks

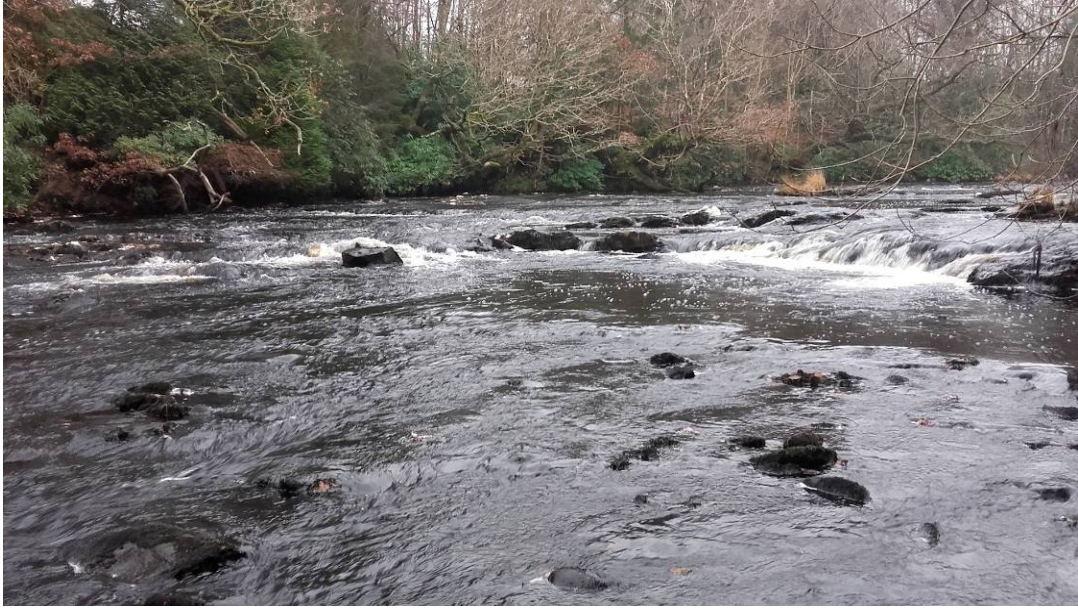
Figure 84: Bedrock falls found at NX 268043 570171.

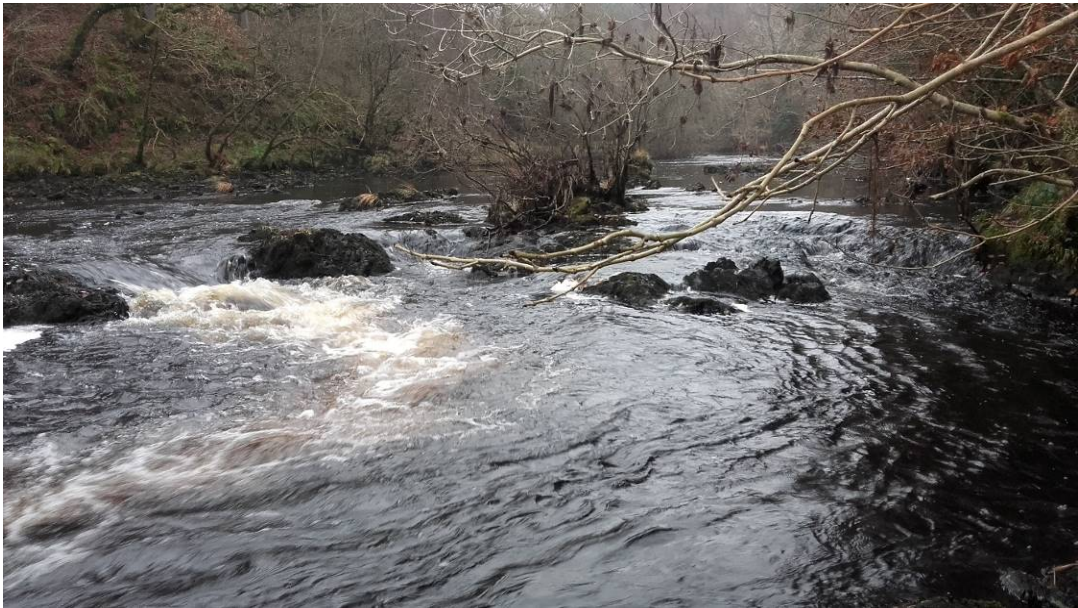
Figure 85: Small falls with bedrock and boulder substrate. Deciduous trees were numerous on both banks (NX 268061 570199)

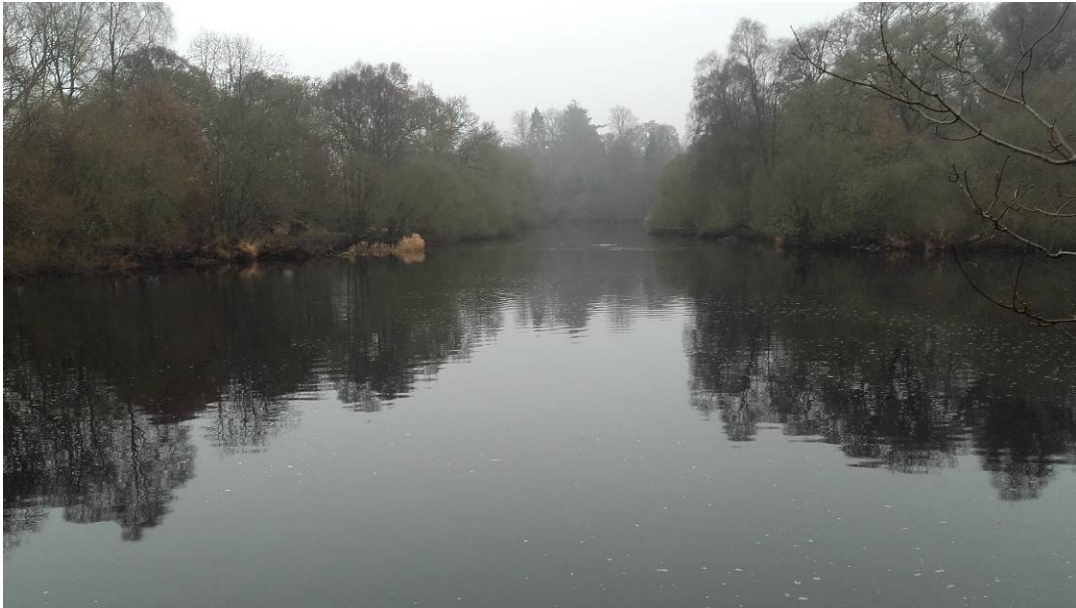
Figure 86: Deep glide that was found at the bottom of the Black Water of Dee (NX 268187 570121) which continued until it reached Loch Ken
